# ENVIRONMENTAL IMPLEMENTATION REPORT / FUNCTIONAL SERVICING STUDY – APPENDICES: VOL.2 (5TH SUBMISSION)

May 2019

14 Mile Creek West and the Lazy Pat Farm Property  
(3269 Dundas Street West), North Oakville West

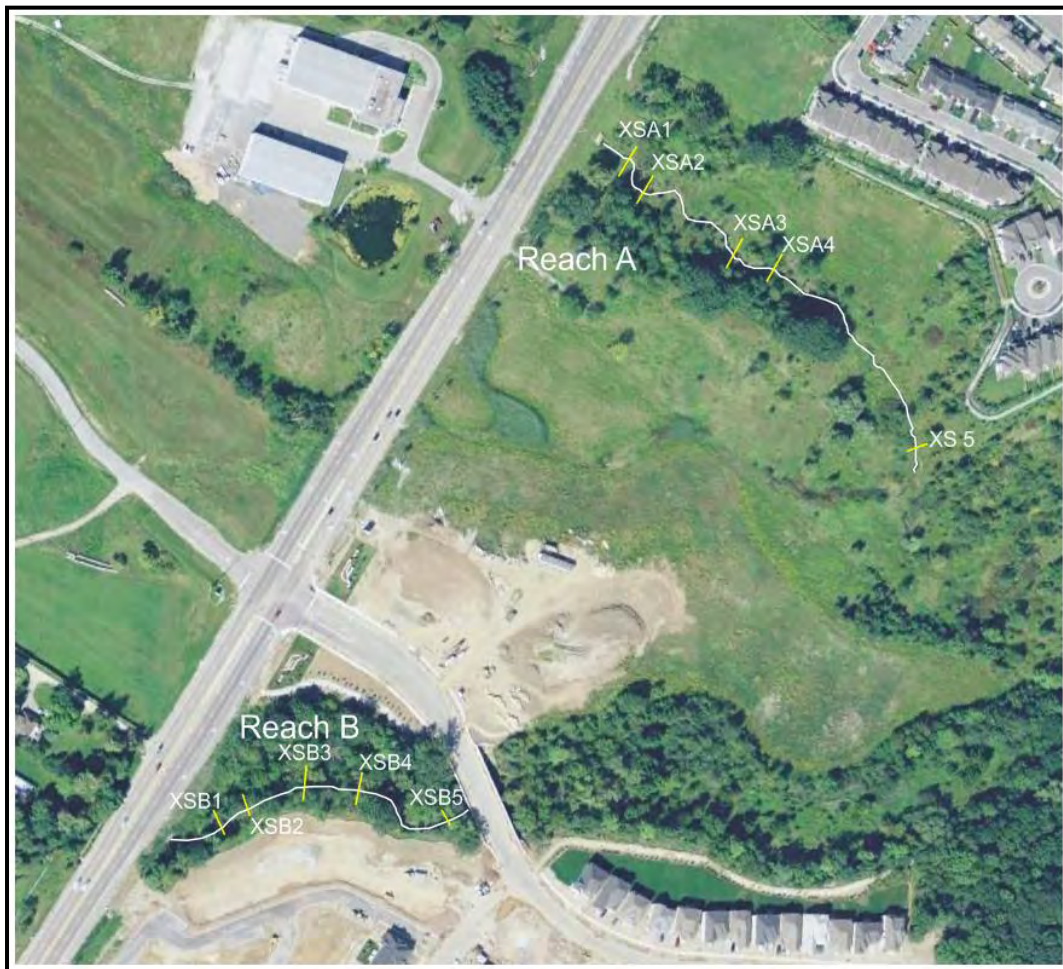
**Figure 2: Location of Reaches and Cross Sections: Reaches A and B**

Cross sections were surveyed within each reach as well. Five cross sections were surveyed for each reach south of Dundas Street. Seven cross sections were surveyed in the west branch of

the tributary north of Dundas Street. The system consists of relatively disturbed reaches; however, there are obvious geomorphic features (i.e. riffles and pools). The surveyed cross sections are detailed in Appendix C. Chainages are noted on each figure.

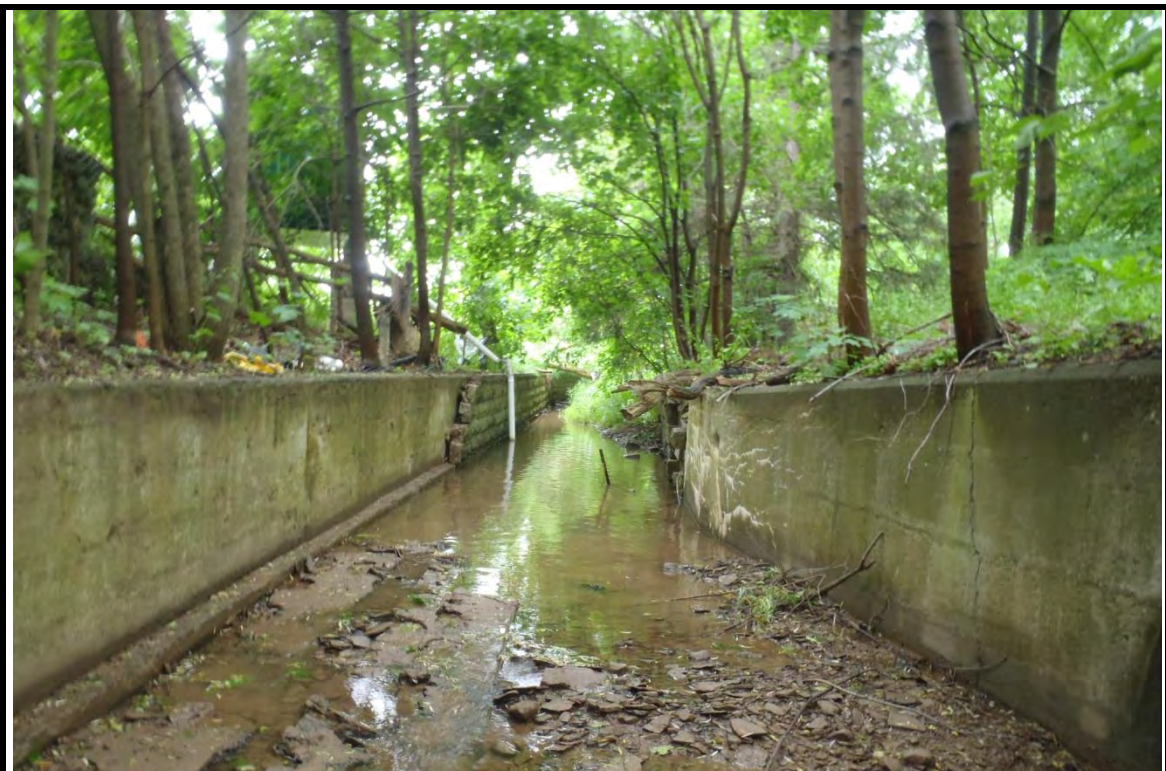
PHOTOGRAPH NO.: 18

LOOKING: AT DOWNSTREAM END OF REACH C

COMMENT: NOTE THE CHANNELIZATION

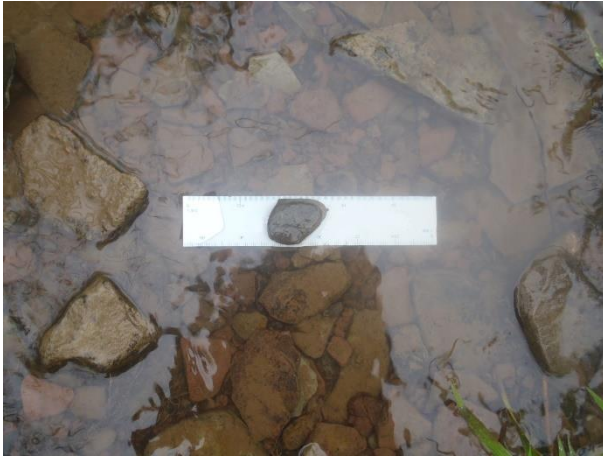
**Photograph 1:** Bed substrate in Reach C

Particle mobility is affected by various factors such as particle pivoting angle, degree of grain exposure and sediment fabric properties such as imbrication and cluster bed forms. These properties vary with the heterogeneity of the channel bed. That is to say that the channel critical shear stress does not only depend on an absolute size of a particle but also on its size relative to the rest of the bed material. (Knighton, 1998). Size selective transport takes place in coarse-grained alluvial streams. Specifically particles that show less exposure, increased imbrication, embeddedness clustering and sheltering of bed particles have a higher erosion threshold and are not transported as easily as they would if the particle bed structures were to be loosely arranged. Photographs 1 to 4 show the armored bed, i.e., granular material in the channel bed. From the photographs, it is clear that the bed structures are not loosely arranged. The larger substrate, particularly those in the  $D_{84}$  range show embeddedness. The substrate smaller than the  $D_{84}$  are not likely to be entrained easily because of the "sheltering" offered by the larger substrate. Therefore, it was determined that if the  $D_{84}$  particle size was to move, it would result in substantial channel adjustment. Hence, this grain size was chosen to determine the critical shear stress and erosion threshold flow.

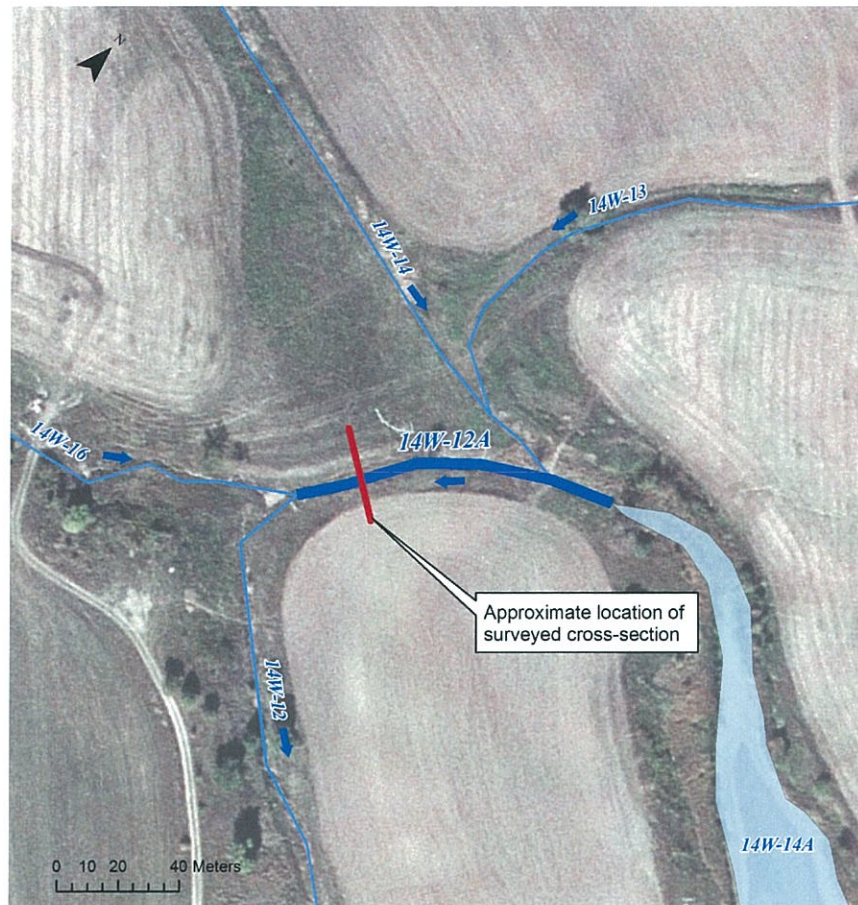
**Figure 2 – Location of surveyed typical cross-section on Reach 14W-12A**

A typical cross-section was surveyed, approximately 90 m downstream from the Pond outlet and 35 m upstream of the Reach outlet into 14W-12 (Figure 2). The cross-section survey confirms the general trapezoidal form of the reach. The left bank and right bank are approximately 2.0 m and 1.6 m high, respectively, with a bank slope of approximately 2:1. Reach bottom width and top width are 5.0 m and 12.0 m, respectively. A small poorly-defined incised channel (0.20 m deep and 0.35 m wide) is located at sta. 8.0 m. This incised channel does not exist within regions vegetated by cattails although overall cross-sectional geometry is similar. Photo 6 was taken of the poorly-defined incised channel in the surveyed cross-section. Photos 3, 4, and 5 represent the typical cross-section and capture the thick vegetation, cross-sectional geometry, and lack of low flow channel definition within the Reach.
