Project File Report
McCraney Creek Bridge Replacement
Municipal Class Environmental
Assessment

# Appendix D: Natural Environment Documentation

Aquatic and Bat Habitat Surveys for Proposed Channel Realignment of McCraney Creek North of Lakeshore Road to Rebecca Street (January 24, 2018)

Class Environmental Assessment Study and Preliminary Design - Lakeshore West Improvements - Aquatic Habitat Existing Conditions Report (October 2017)

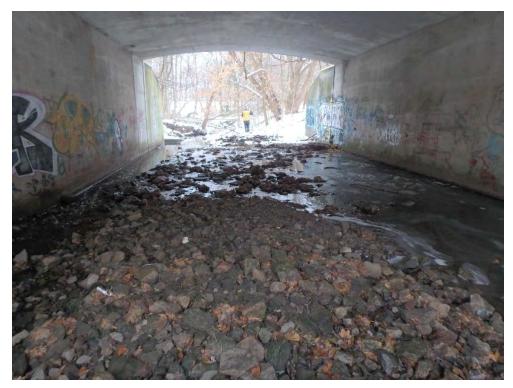
**Photo 1:** Within Rebecca Street ROW facing downstream. Note large area of debris at west downstream end of crossing forcing flows to move over cement ledge on east.

Immediately downstream of Rebecca Street, there is a vertical drop where the poured concrete slab foundation of the crossing meets the natural stream substrate. Flows at the outlet of the crossing structure are concentrated on the easternmost side of the crossing where they flow over this structure, as a large accumulation of woody debris and leaves blocks the majority of the channel at the westernmost side of the crossing outlet. The vertical drop from the poured cement slab to the natural stream substrate is approximately 0.5 m high on the west and 0.8 m high on the east. This area of concentrated flow exhibits a higher velocity then the surrounding watercourse and laminar flow is present. As such, this feature is a barrier to the upstream movement of small-bodied fish. The effects of this barrier would be exacerbated during periods of high flow.

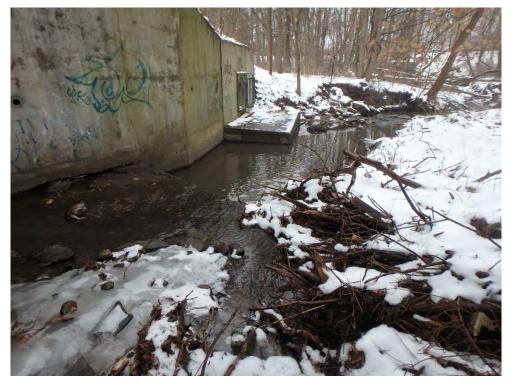
**Photo 2:** Cement slab present at downstream end of Rebecca Street crossing is a barrier to small-bodied fish.

- Select a new replacement structure that will improve fish passage:
  - Consider flow velocities and select the structure, grading, etc. that will ensure the crossing structure is passable by fish species known to inhabit the watercourse which include smaller-bodied species which may move through the watercourse seasonally based on stream temperatures and are capable of low/moderate swim speeds (i.e. Longnose Dace 0.65 meters per second (m/sec) and White Sucker 0.45-0.60 m/sec). Rainbow Trout, a sensitive cool/coldwater species has also been found within the watercourse and is likely migrating through the study area to reach upstream breeding grounds. This species can move up to 5.70 m/sec (Peake, S.J, 2008).

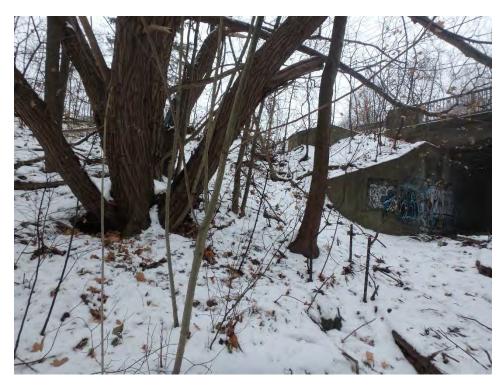
Photo 3: Photo of stable west bank at Rebecca Street.

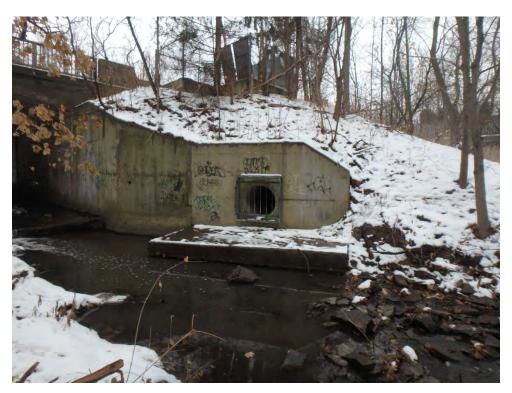
Photo 4: Photo of stable east bank at Rebecca Street.

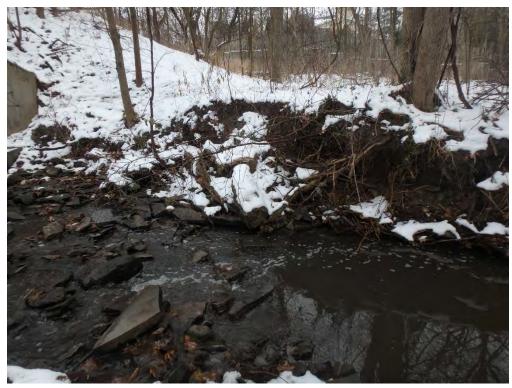
**Photo 5:** Erosion evident at east bank immediately downstream of Rebecca Street retaining wall. Area spans approximately 10.3 m in length. Height of erosion averages at 1 meter.

Immediately downstream of this area past the southwest headwall of the Rebecca Street crossing, erosion is evident along the east bank of the watercourse, spanning a length of approximately 10.3 m. Unstable soil and exposed roots are evident up to a height of approximately 1 m. The west bank was stable in this area. No further erosion was observed on the easternmost bank approaching the Lakeshore Road ROW.

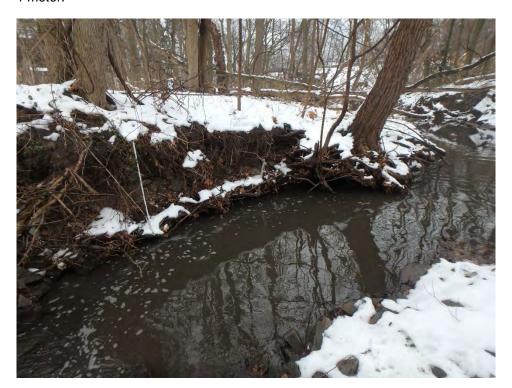
**Photo 6:** Erosion evident at east bank immediately downstream of Rebecca Street retaining wall.

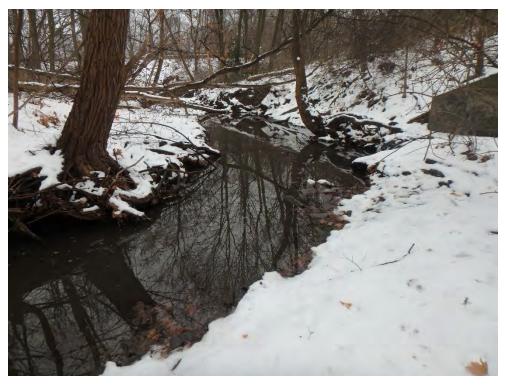
Photo 7: Downstream banks stabilize before erosion area present on west bank.

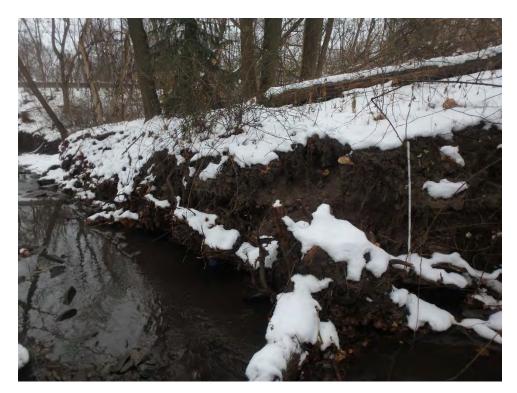
**Photo 8:** Erosion evident on west bank for approximately 31.5 meters prior to reaching retaining wall for Lakeshore Road.

Downstream of this area, erosion became evident on the west bank of the watercourse, with exposed soils and bare roots evident spanning along approximately 31.5 m of channel. The unstable banks were approximately 1m high. As the watercourse approaches the tight bend at Lakeshore Road, the erosion becomes more severe with the greatest amounts of erosion found at the crest of the turn where McCraney Creek transitions its flow from a southerly direction to an easterly direction as it reaches the Lakeshore Road ROW. The bank height, through this area reaches a maximum height of approximately 2.5 m.

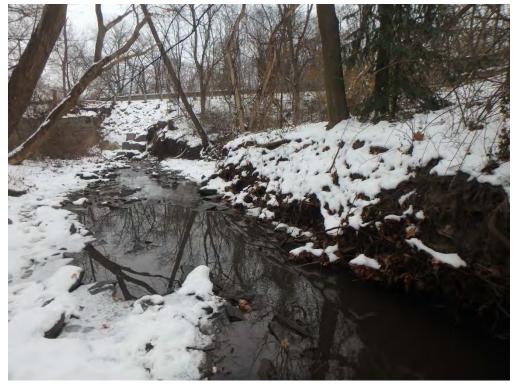
Photo 9: Erosion evident at west bank on approach to Lakeshore Road ROW.

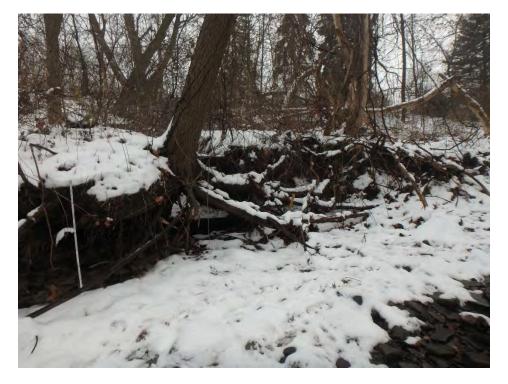
Photo 10: Close up or exposed roots present on west bank.

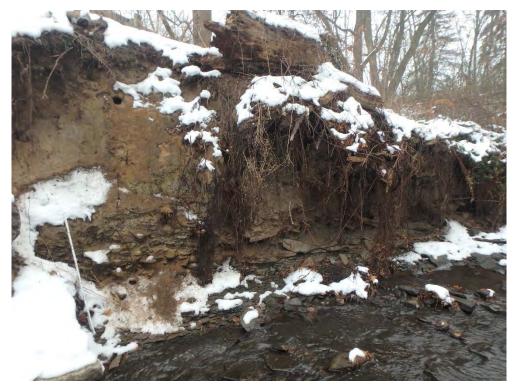
**Photo 11:** Bank nearest the retaining wall structure experiencing significant erosion. Erosion of bank reaches approximately 2.5 meters in height at its highest point.

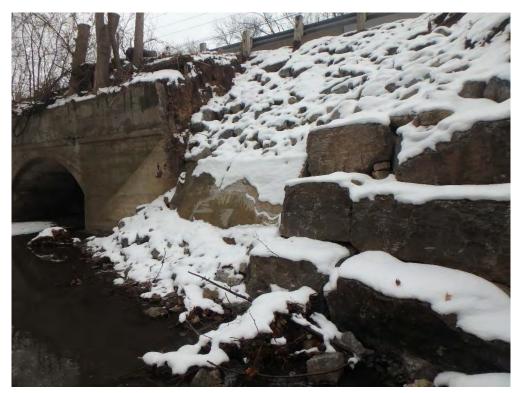
**Photo 12:** Emergency works were completed in the summer of 2017 to repair the severely eroded bank present directly west of the Lakeshore Road crossing.

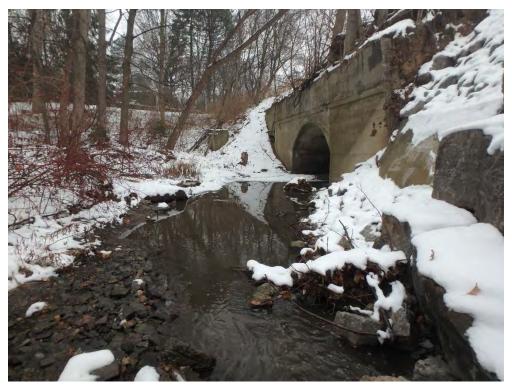
**Photo 13:** Upstream end of Lakeshore Road crossing. Note some erosion is also evident at northeast bank, where exposed sandy soils are present.

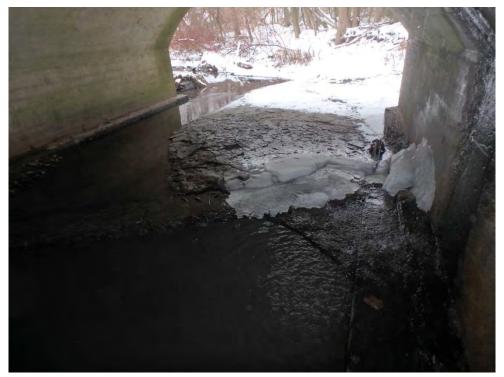
**Photo 14:** Standing within Lakeshore Road ROW facing upstream. Note large area of limestone present to right (east) of structure inlet. Cement slab located at left may pose a potential barrier to smaller-bodied fish during periods of high flow.
