ENVIRONMENTAL IMPLEMENTATION REPORT / FUNCTIONAL SERVICING STUDY - MAIN REPORT (4TH SUBMISSION)

June 2017

14 Mile Creek West and the Lazy Pat Farm Property (3269 Dundas Street West), North Oakville West

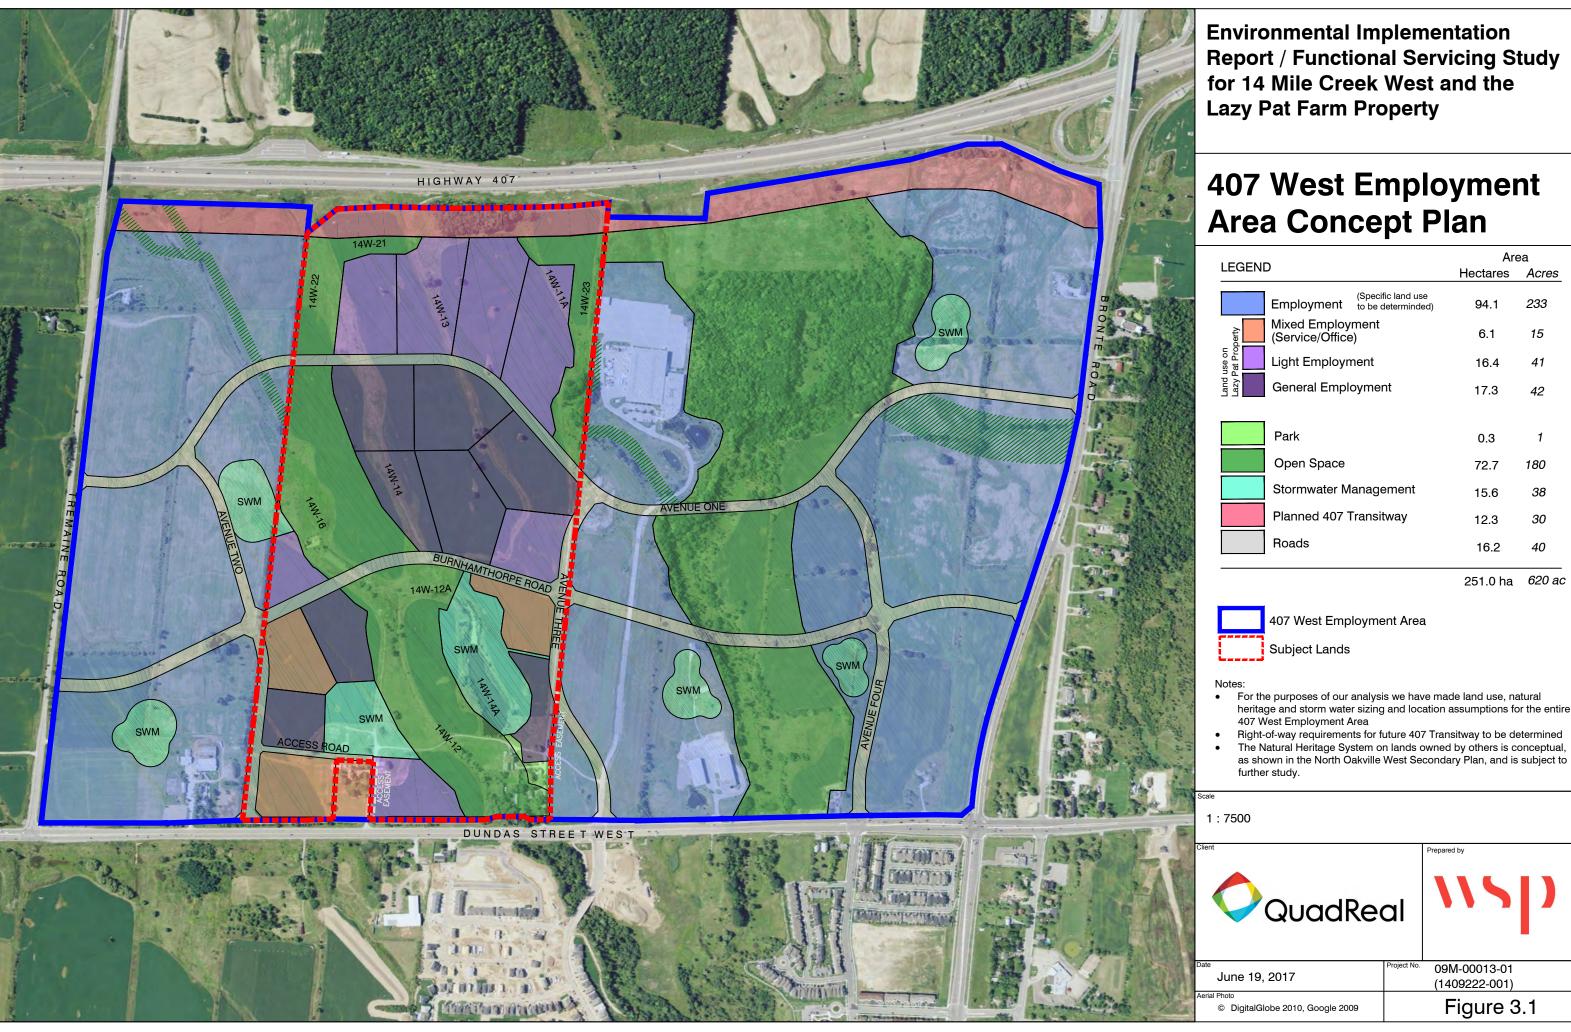
09M-00013-01 (1409222-001) Figure 3.1

Figure 3.1 illustrates the concept plan for the Study Area based on the direction of the Town's NOWSP. The concept plan for the Study Area is generally consistent with the Town's NOWSP and Master Plan and incorporates modest revisions to the proposed road network based on further study. The road pattern follows a modified grid pattern which responds to the existing environmental and site conditions while encouraging accessibility and a viable transit network throughout the 407 West Employment area. The conceptual road network identified in the NOWSP does not provide a sufficient network to facilitate the appropriate development of the 407 West Employment Area, based on more detailed study undertaken through this EIR/FSS. WSP (formerly MMM) has provided various comments to the Town in relation to the NOWSP road pattern, and based on these discussions with the Town it was recognized that the road network is conceptual and may be further refined, this is further supported by the policies of the NOWSP. Modifications to the road network have been proposed to: minimize the impact on the existing GE Facility site and operations, by shifting Avenue One to the south; minimize the impacts on the NHS by shifting the Burnhamthorpe Road alignment north of the High Constraint Stream Corridor and existing Farm Pond on the Subject Property, and modifying the road alignments to accommodate appropriate access to larger sized employment blocks, particularly to the north of the planning area.

407 West Employment Area Concept Plan

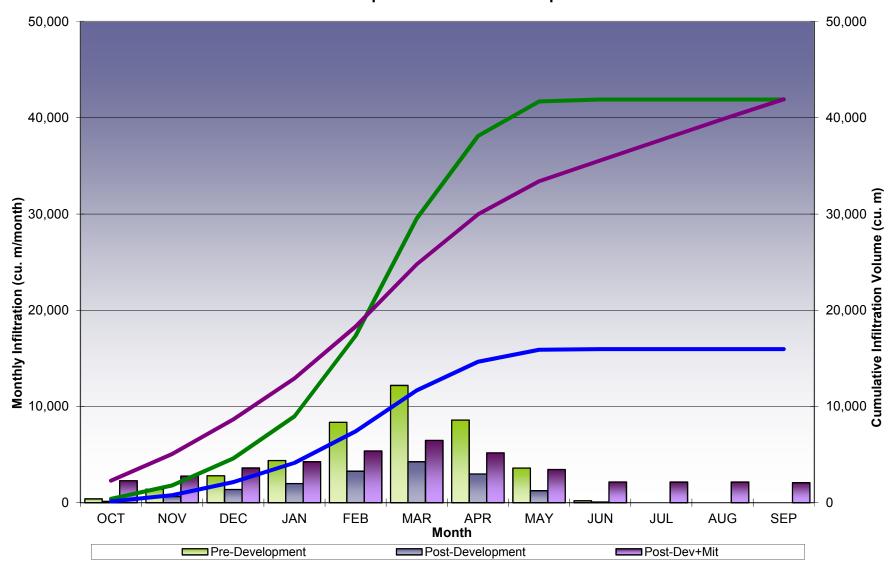
Figure 4.9: Monthly and Cumulative Infiltration - bcIMC Lands within FM1001 Pre-Development and Post-Development

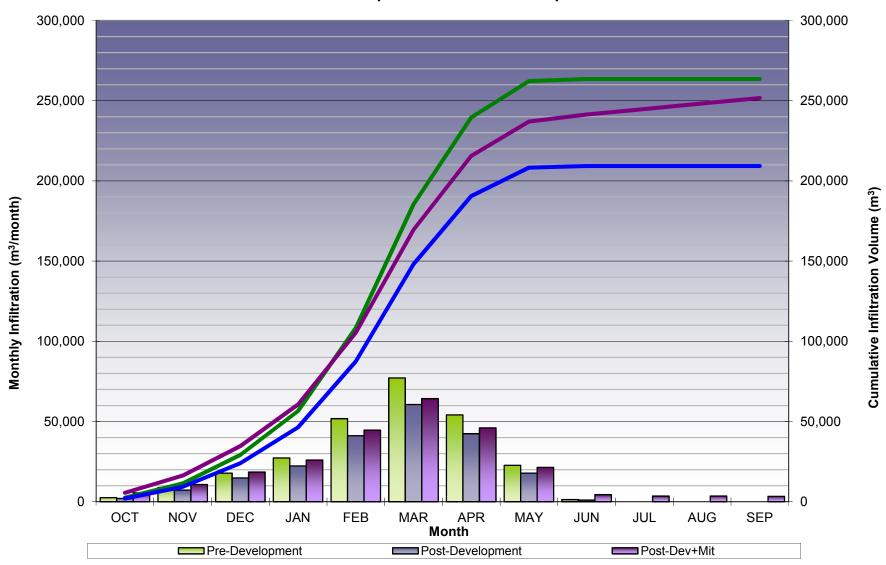
Figure 4.10: Monthly and Cumulative Infiltration - FM1001 Subwatershed Pre-Development and Post-Development

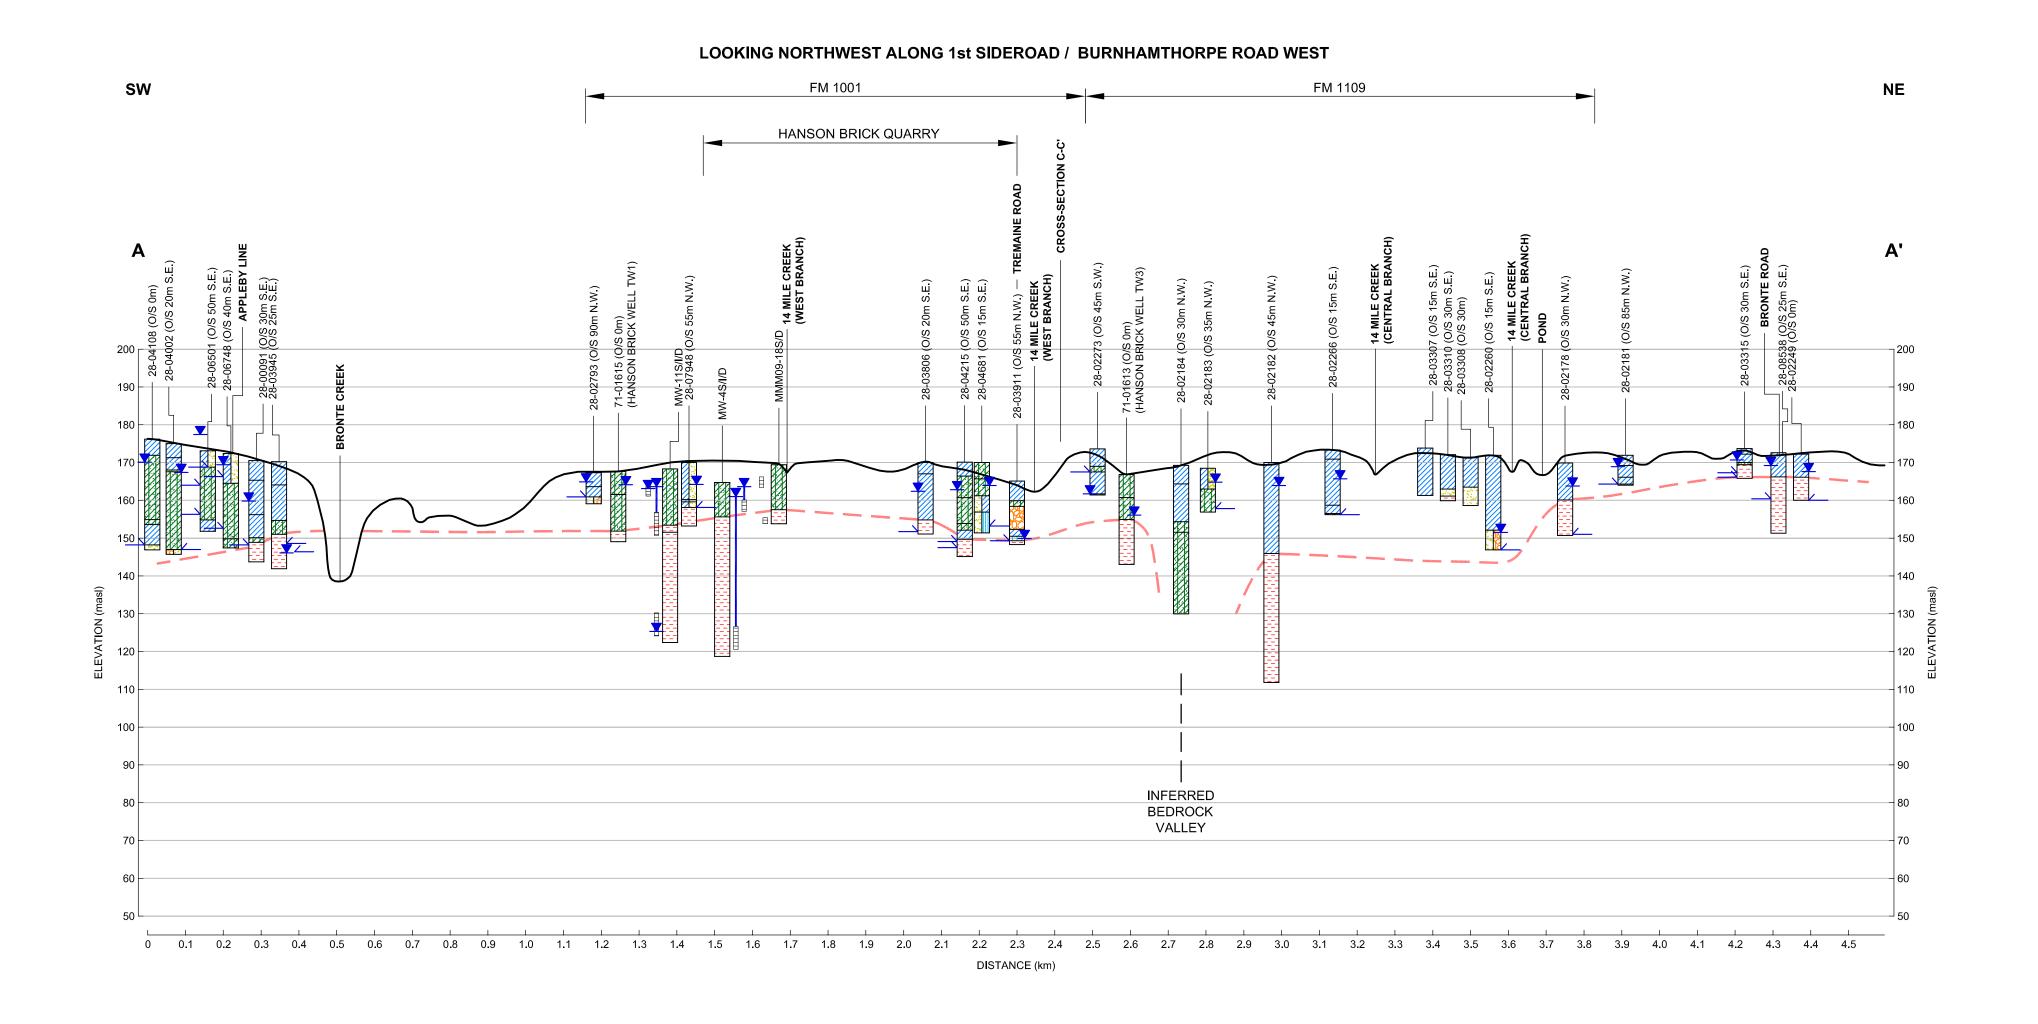
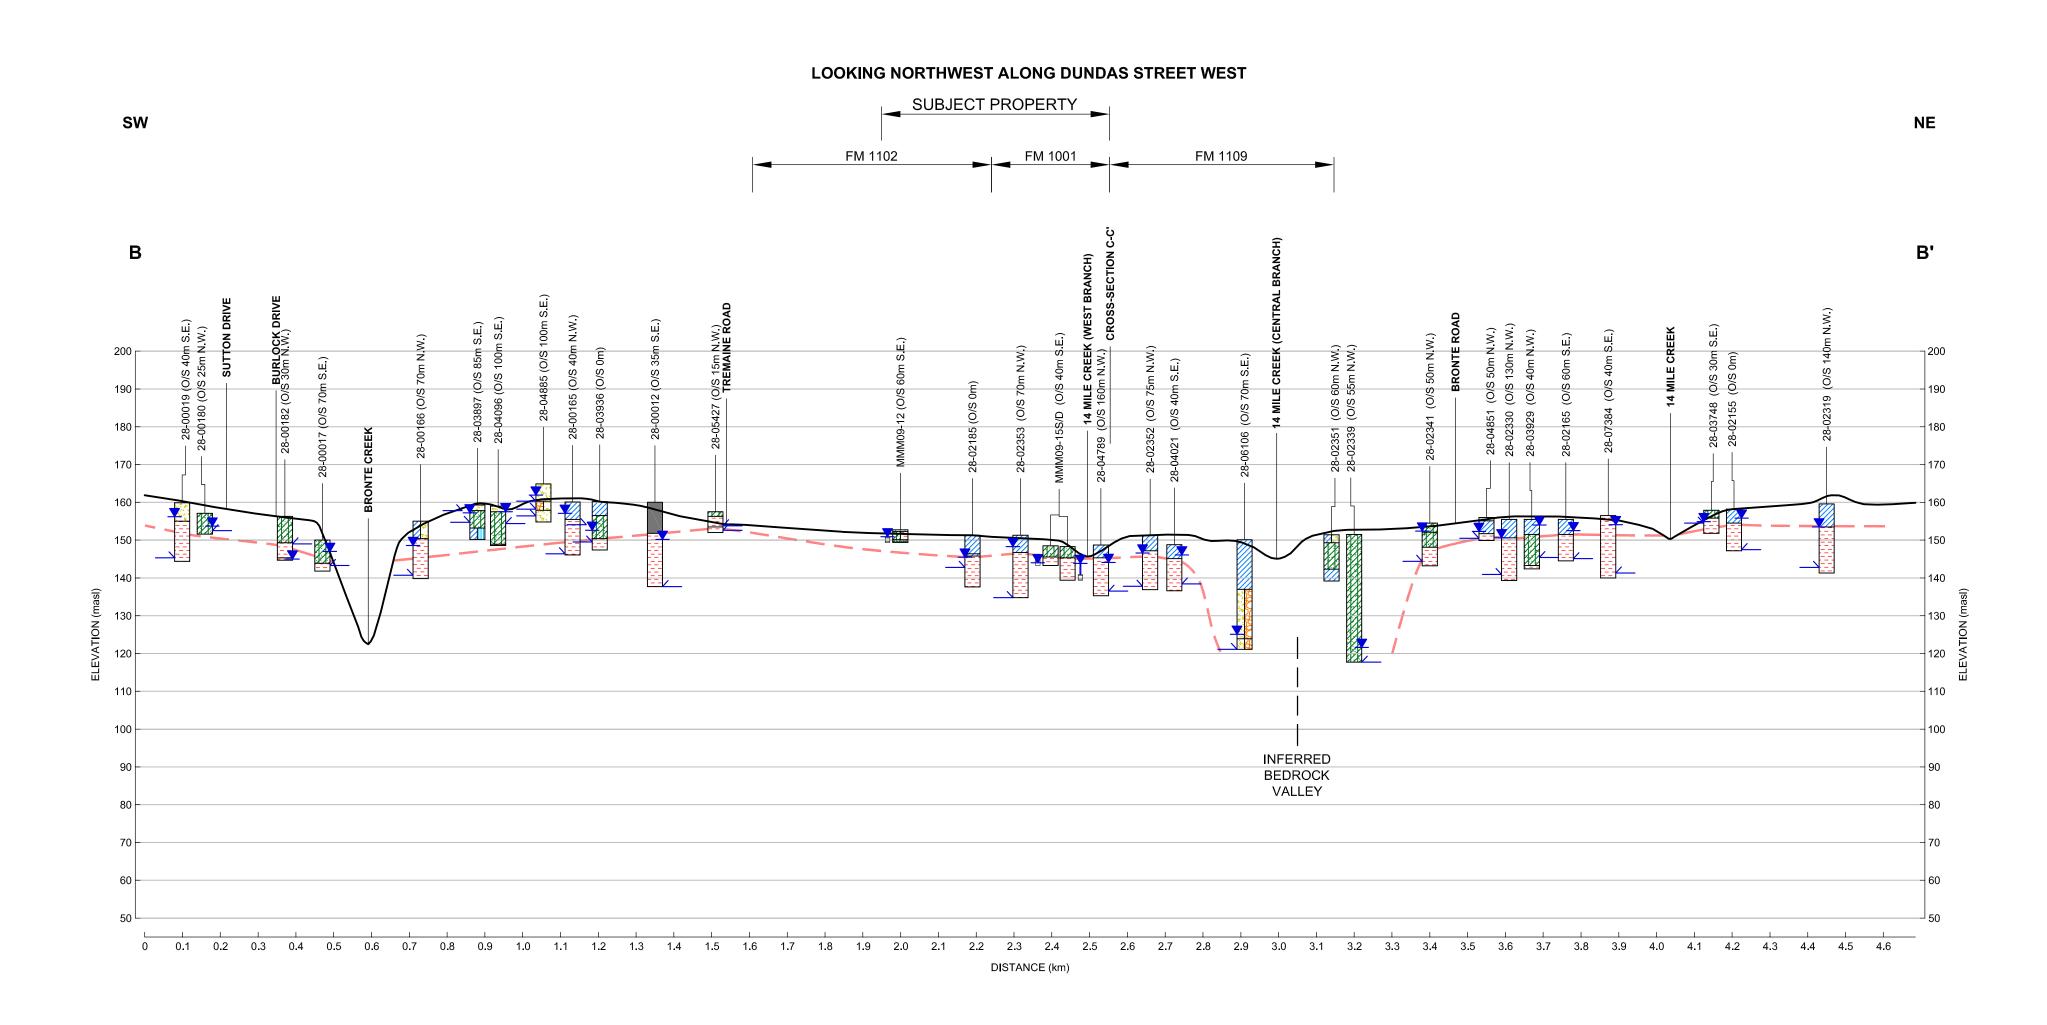
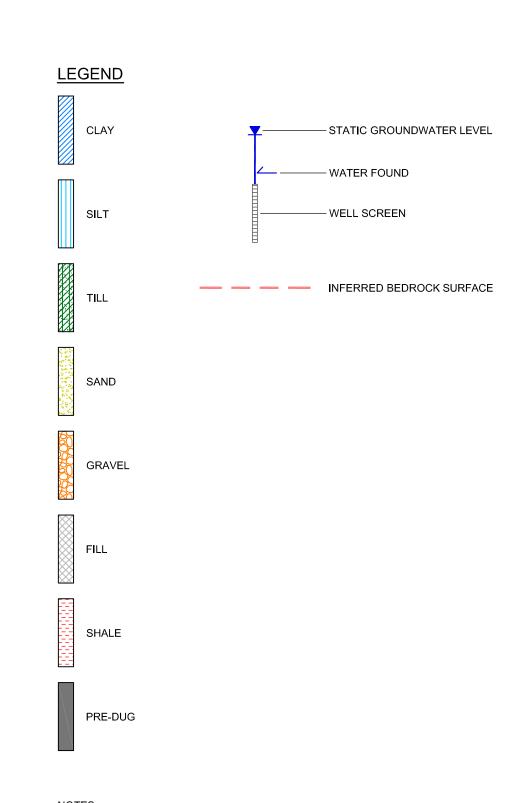
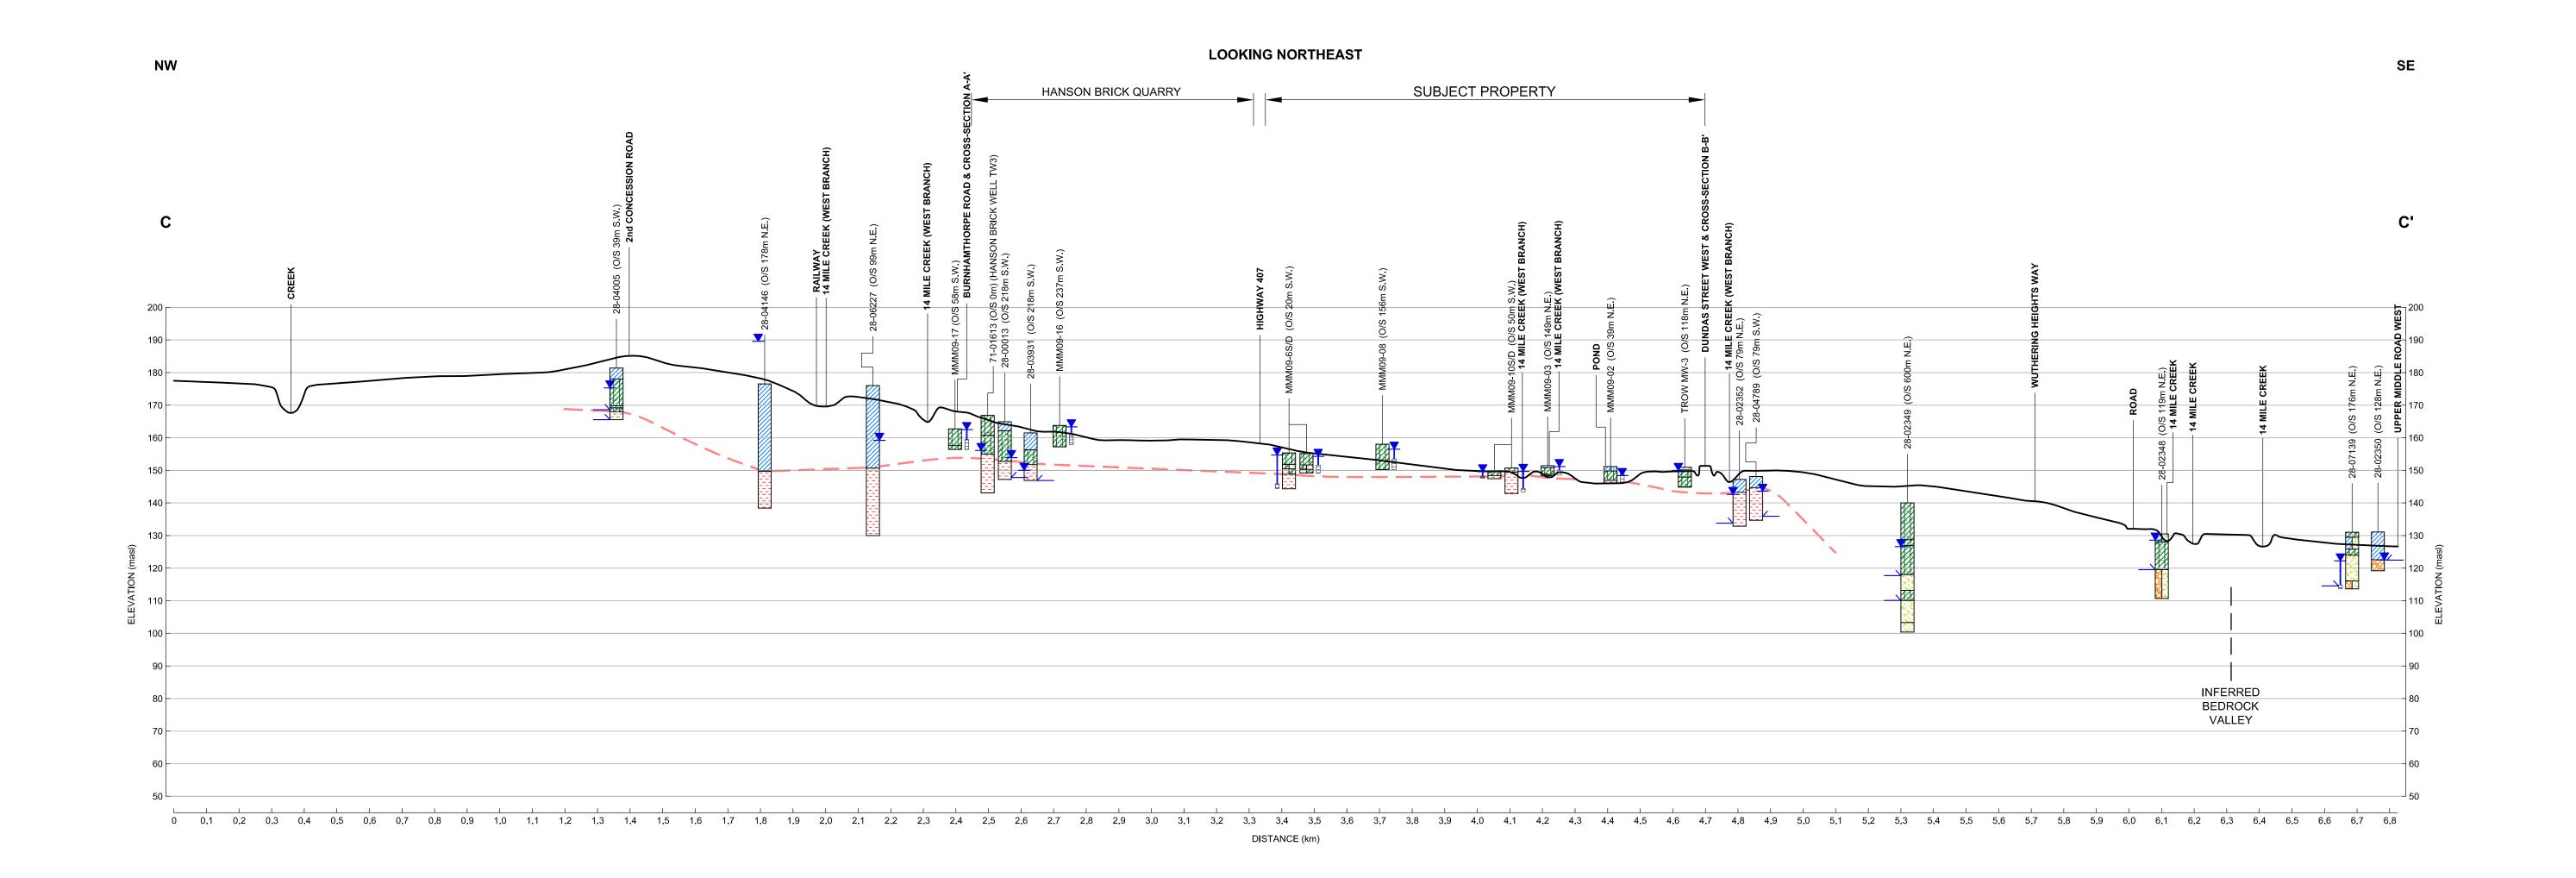
Hydrogeologic Cross-Sections A-A', B-B' and C-C'

NOTES:
- MANUAL WATER LEVES FOR MMM AND TROW MONITORING WELLS
WERE MEASURED ON APRIL 13, 2010
- MMM AND TROW WELLS WERE PROFESSIONALLY SURVEYED
