PHASE ONE
ENVIRONMENTAL SITE ASSESSMENT
106 – 114 ROBINSON STREET AND 71 WATER STREET
OAKVILLE, ONTARIO

File No 1-22-0230-41
May 03, 2022
©**Terraprobe Inc.**

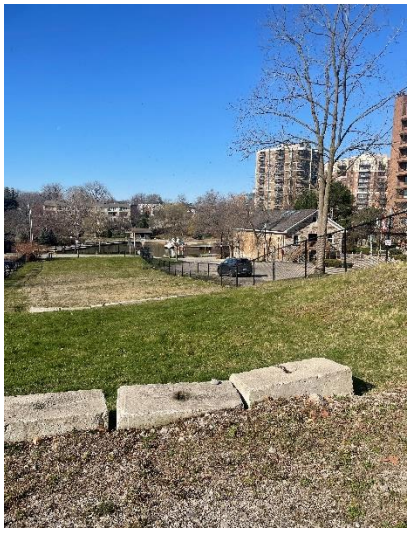
Photograph 1

Location:	106-114 Robinson St. & 71 Water St.(The Property)
Viewing:	North
Description:	Steep terrain and concrete retaining walls inside the Property located at 104-114 Robinson St.

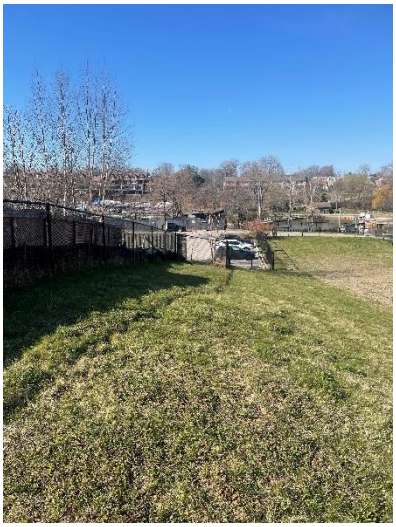
Photograph 5

Location:	106-114 Robinson St. & 71 Water St. (The Property)
Viewing:	Southwest
Description:	The interior, west of the Property, and parking lot southwest of The Property
