# Functional Servicing Report

Former Oakville Trafalgar Memorial Hospital Lands 327 Reynolds Street

Town of Oakville

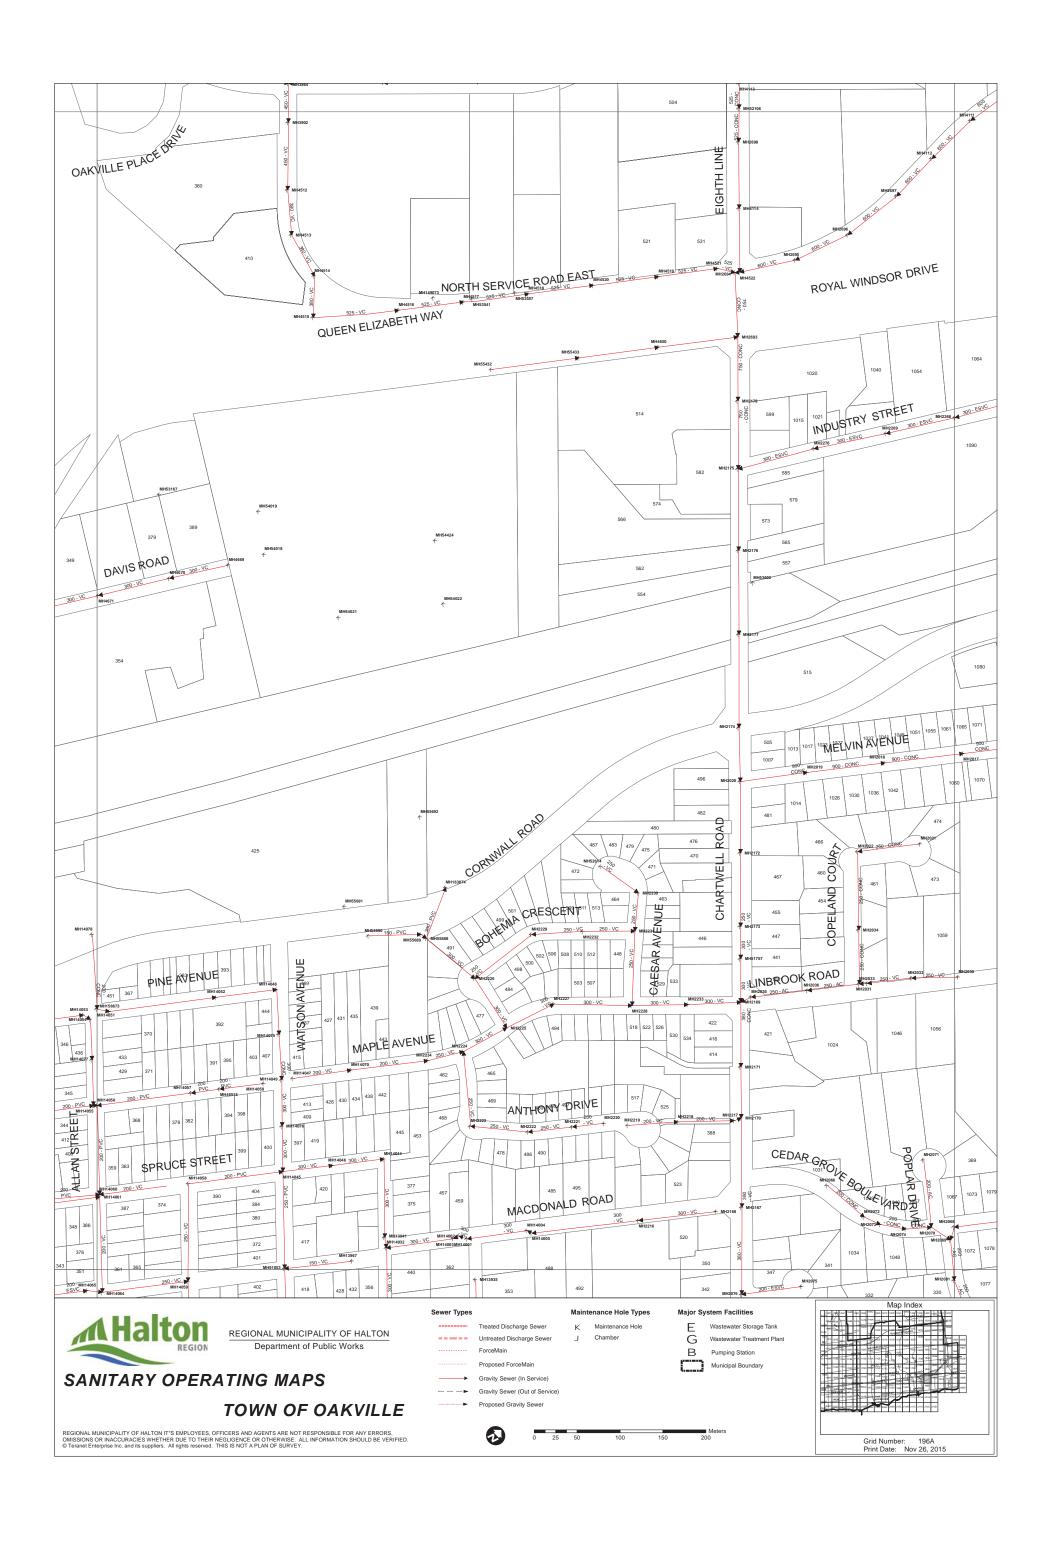
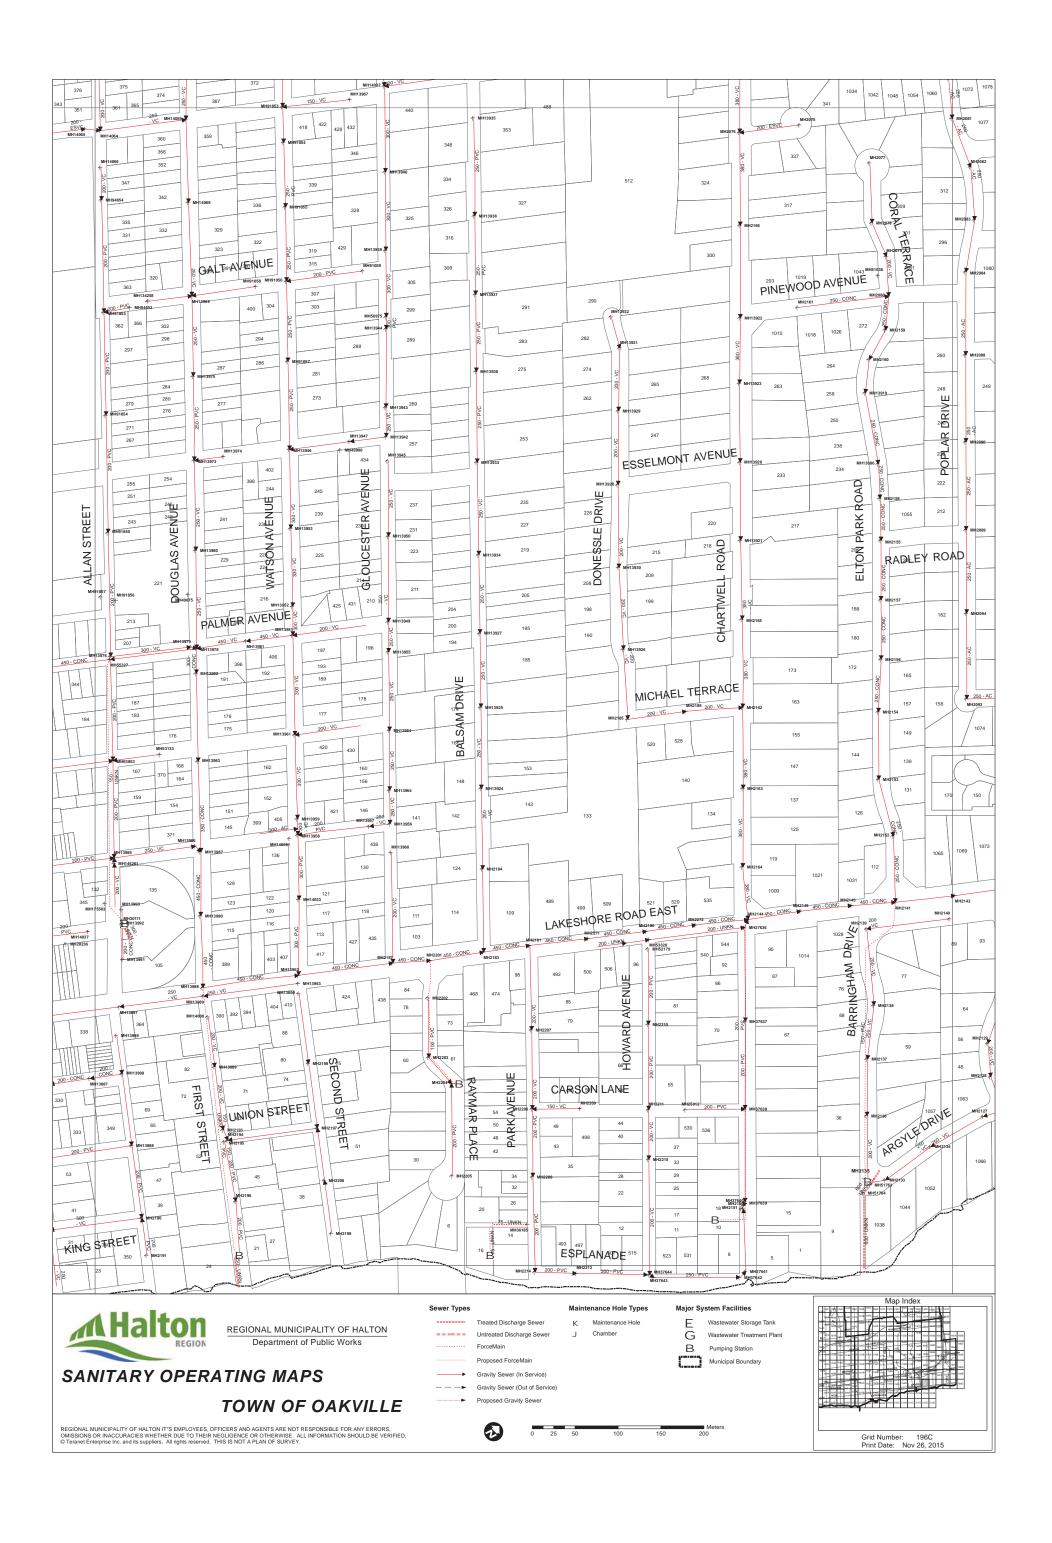
Project:	OTMH Site			
Project No:	11148742			CHD.
Date:	30-Nov-17			GITTE
OTMH Site - Existi	ng Sanitary Flow			
Site Area =			5.7	ha
Total Beds as Per (	Online Records			beds
		Water Design Manual, 2017) =		
Population 4 person		,	1468	
Peaking Factor (co			2.95	
Infiltration =			0.000286	m³/ha/s
			0.0016302	
				L/s
Average Sewage F	low =		0.00001270	m³/bed/s
			0.005	m3/s
			5	L/s
Average Sewage F	low * Average Peak Flow		13.7	L/s
Peak + Infiltration	Flow =		15.4	L/s
Total Flow to Law	son Street		15.4	L/s

Project:	OTMH Site		
Project No:	11148742		CHIE
Date:	30-Nov-17		CHD
OTMH Site - Prop	posed Sanitary Flow		
A. Community Si	10 Avon =	1	ha
	Region Water and Waste Water Design Manual, 2017) =		pers/ha
	er + Senior Residence Population =		persons
Peaking Factor =	er i Semor Residence ropulation –	4.33	•
Infiltration =		0.000286	
inilitration =

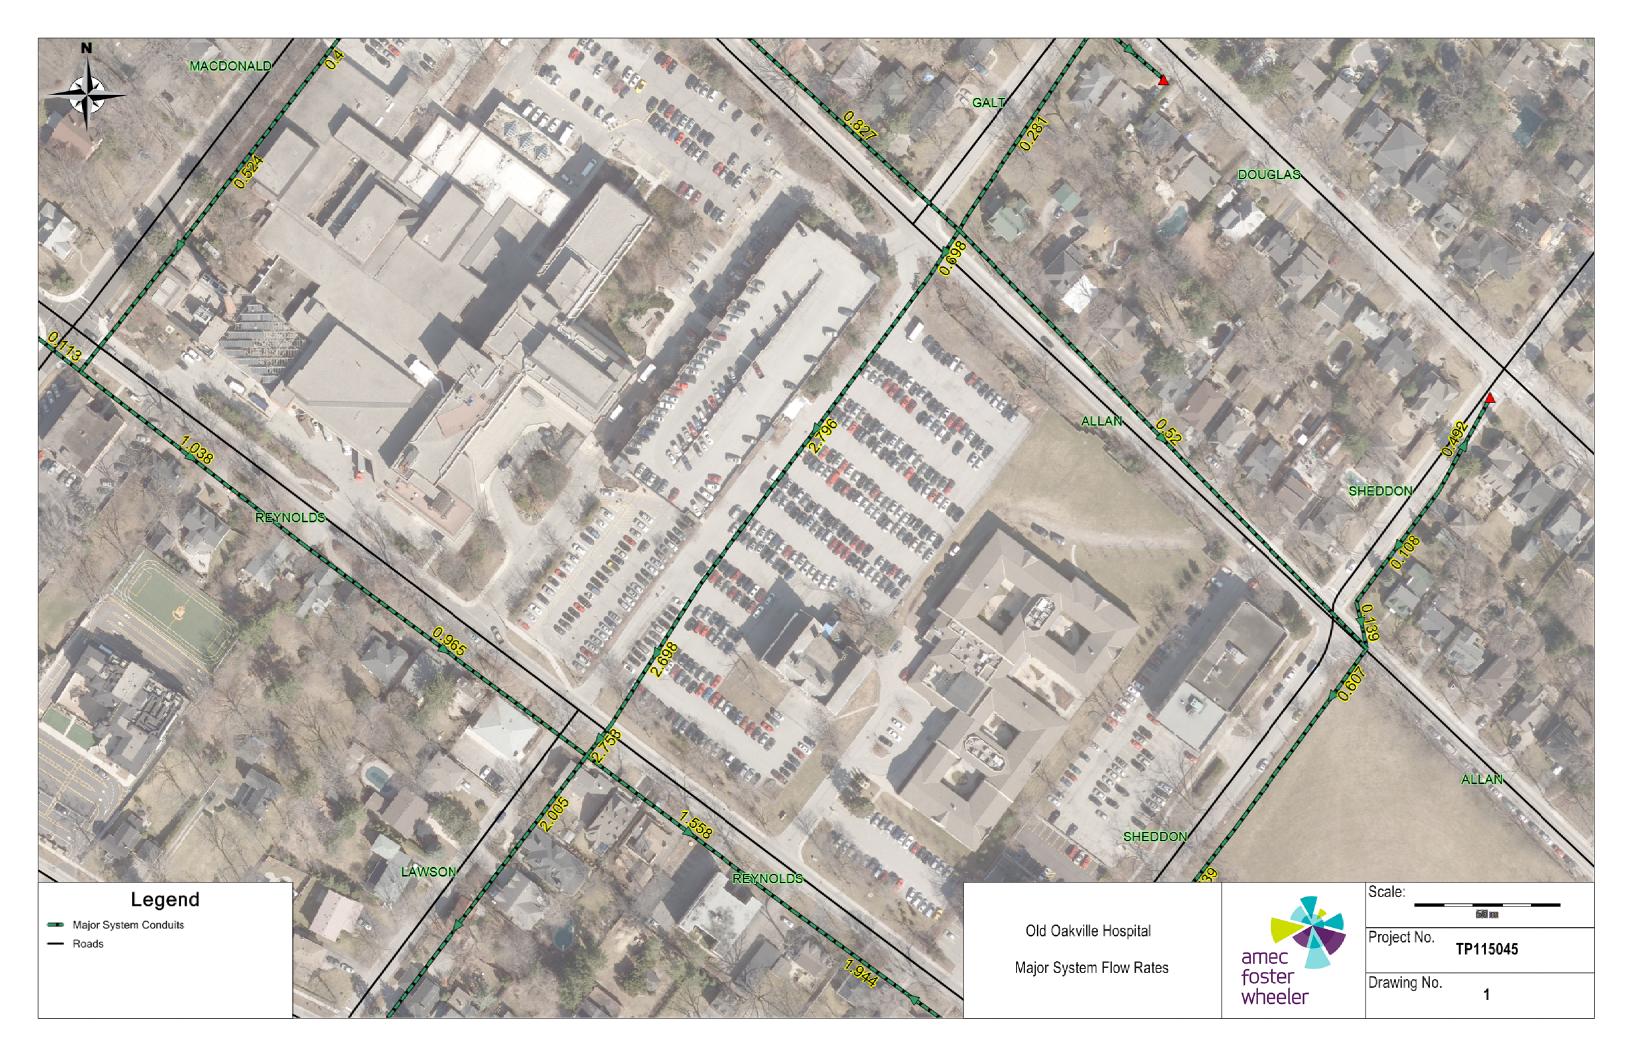
TOWN OF OAKVILLE FORMER OAKVILLE-TRAFALGAR MEMORIAL HOSPITAL LANDS PROPOSED SOUTH SWALE EXTERNAL FLOWS 11148742-00
