Environmental Implementation Report / Functional Servicing Study for 14 Mile Creek West and the Lazy Pat Farm Property

Existing Channel System, And Proposed Channel Diversion and Rehabilitation

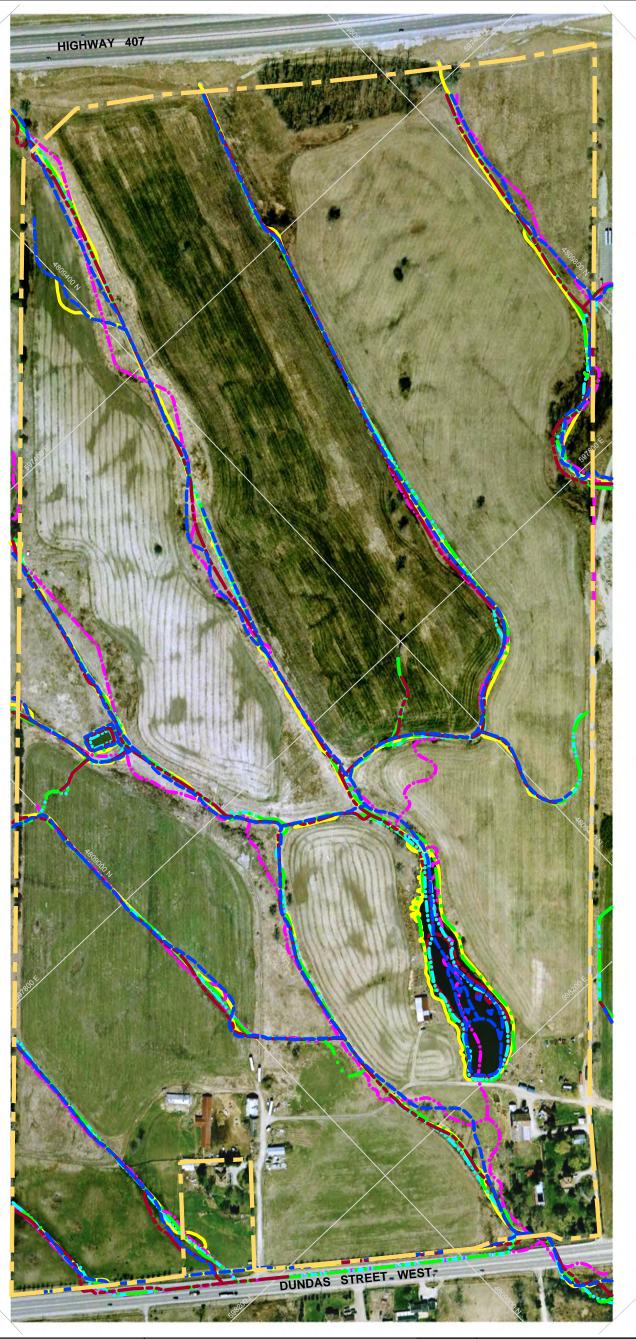
**Historical Channel Planform**

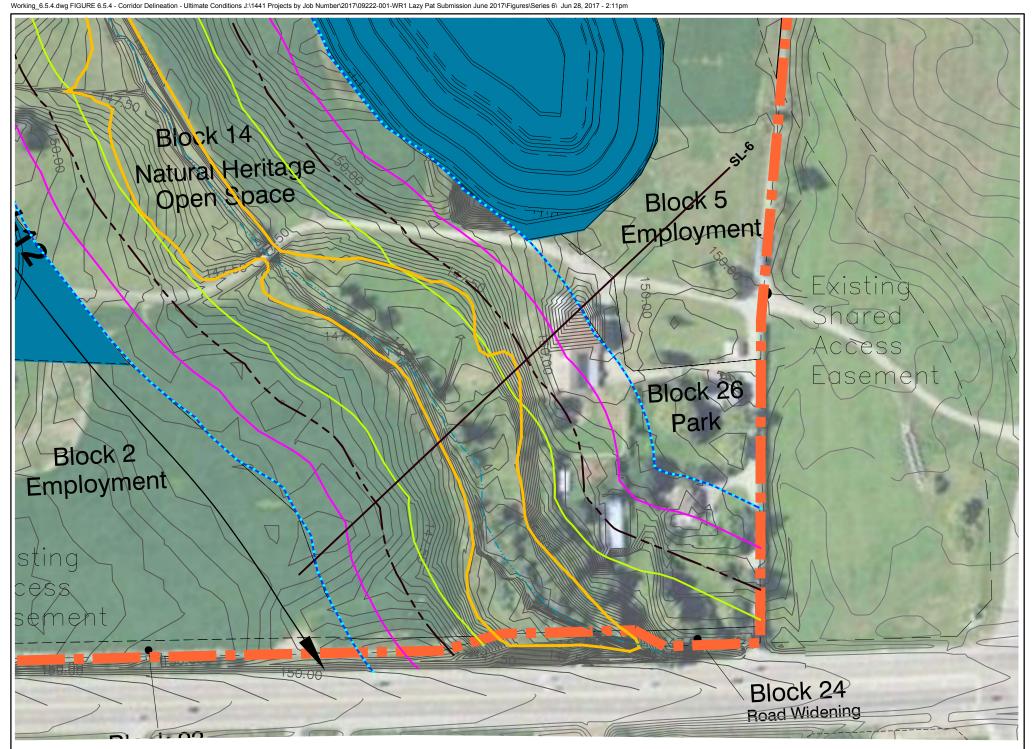
# **Cross Section SL-6 (looking downstream)**

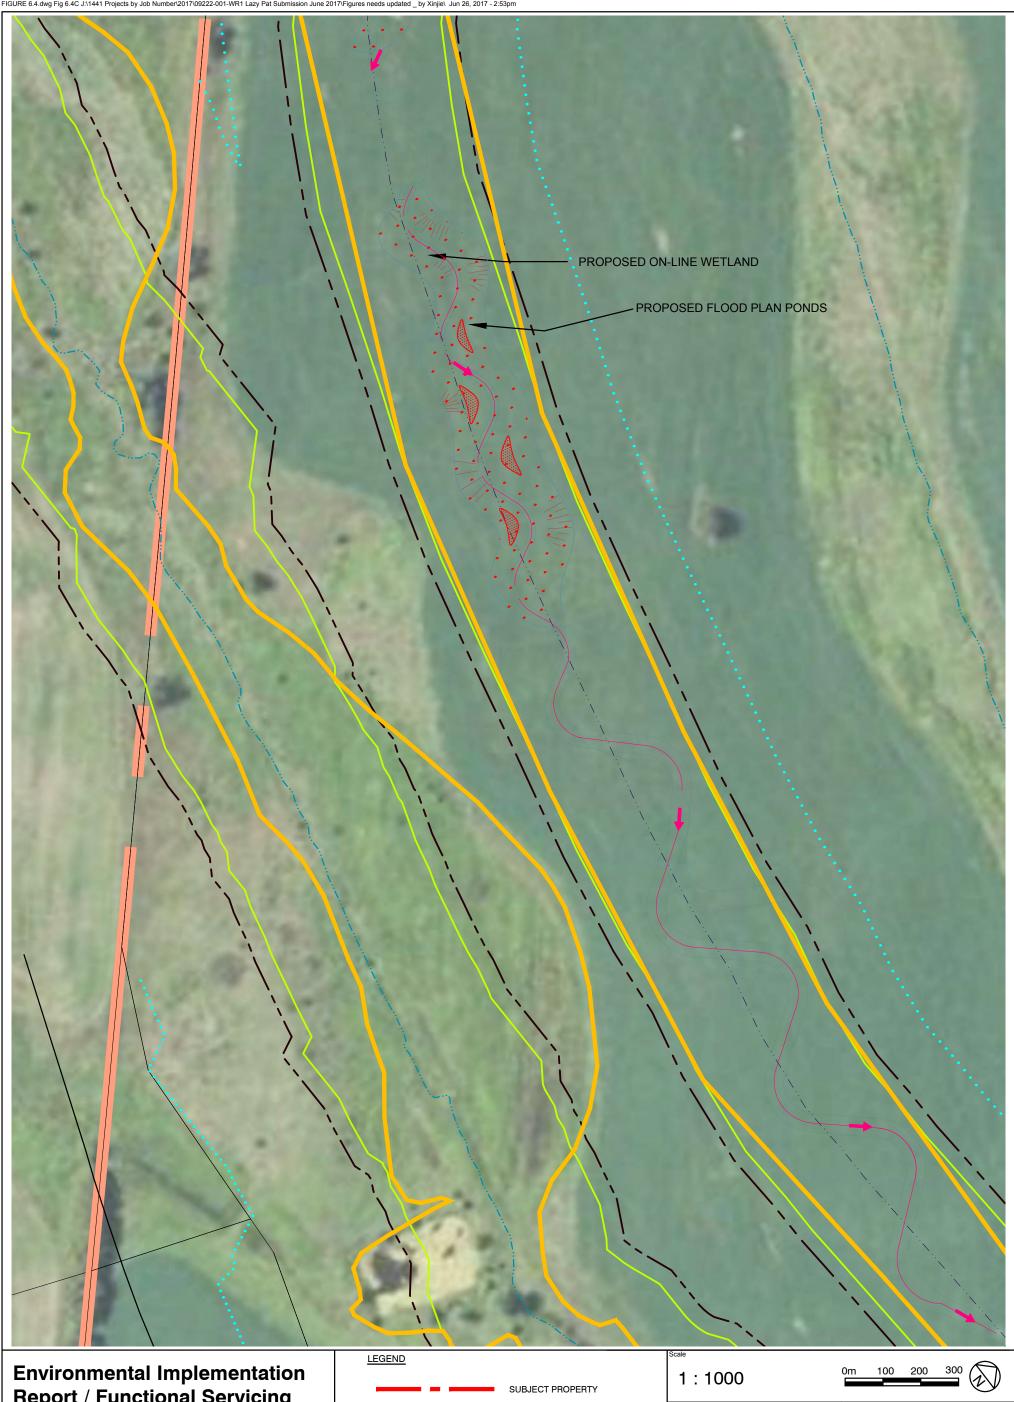
Diversion Channels 14W-22 And reach 14W-16 Rehabilitation Alignment And Planform

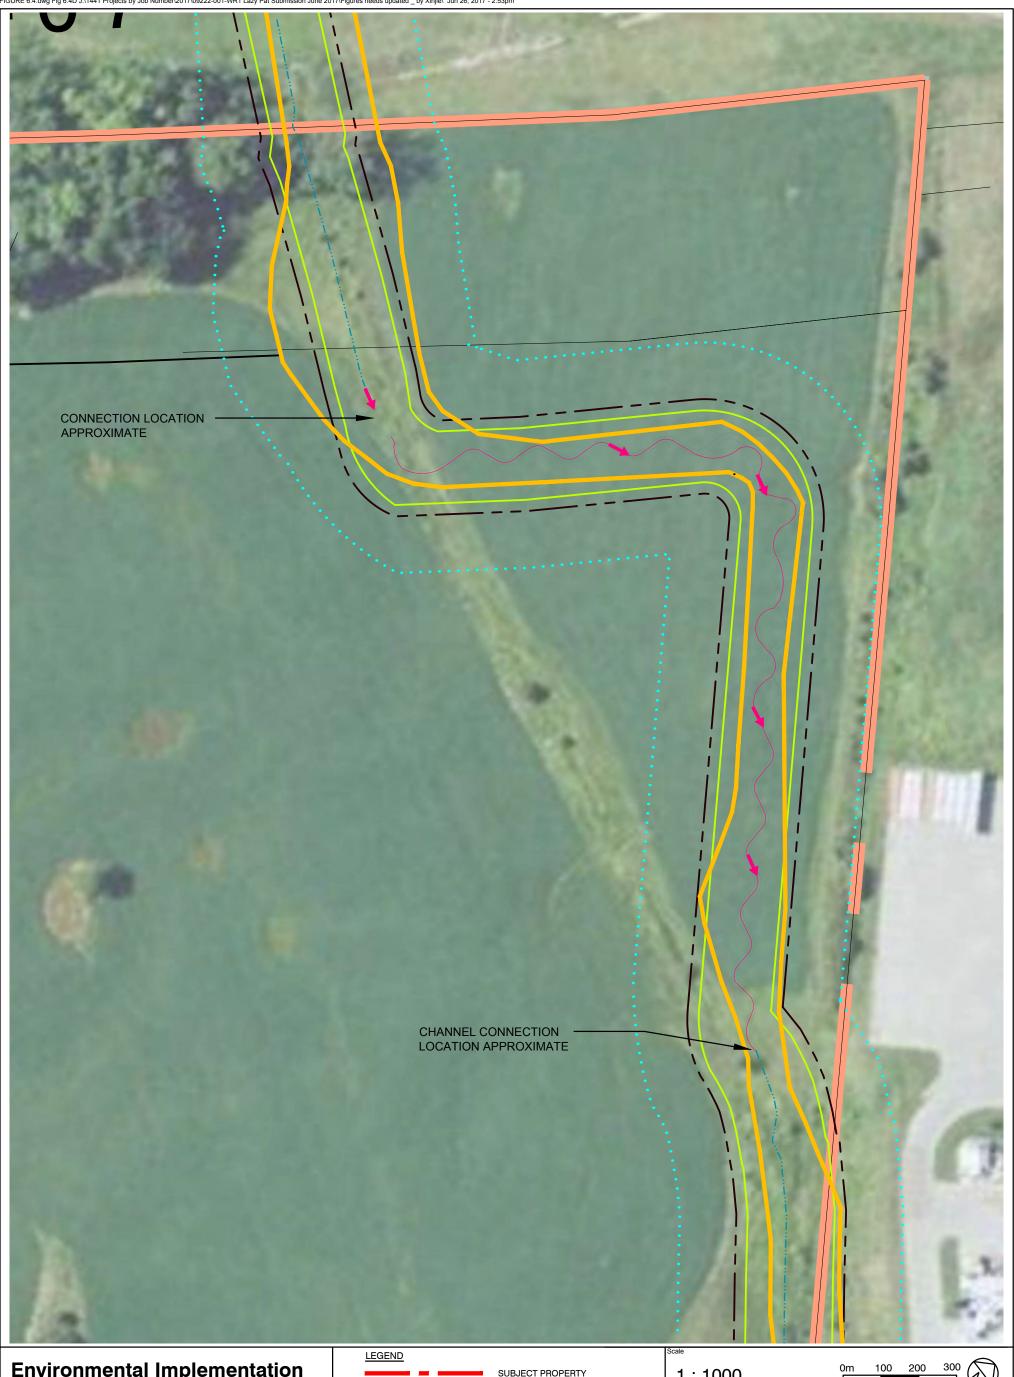
Diversion Channels 14W-23 and 14W-11 Alignment And Planform

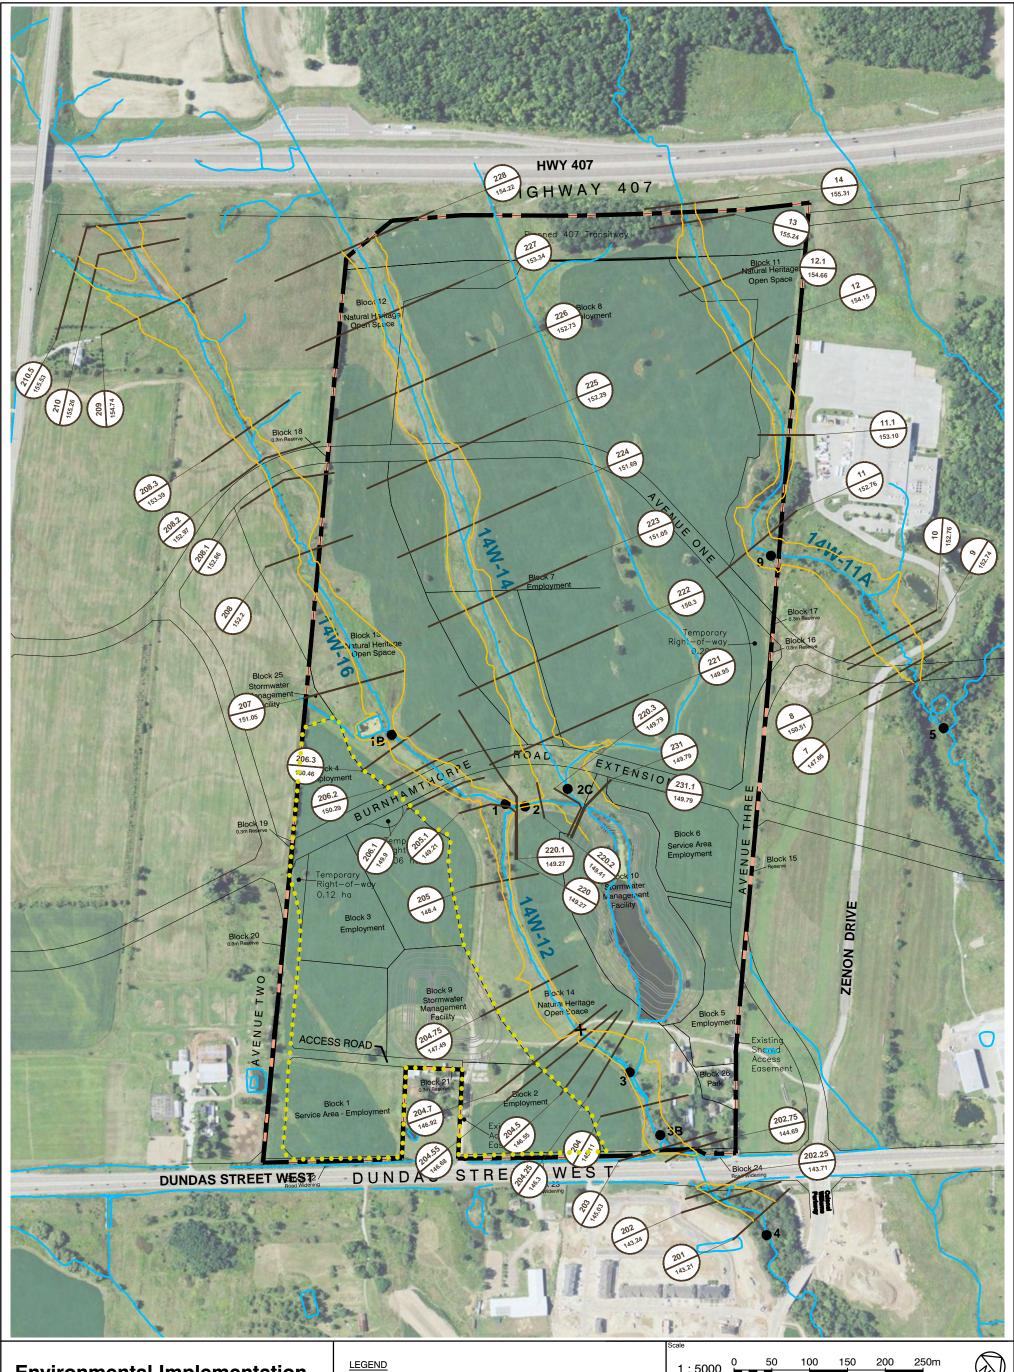
Hec-Ras Cross-Sections
Interim Phase 1A Conditions

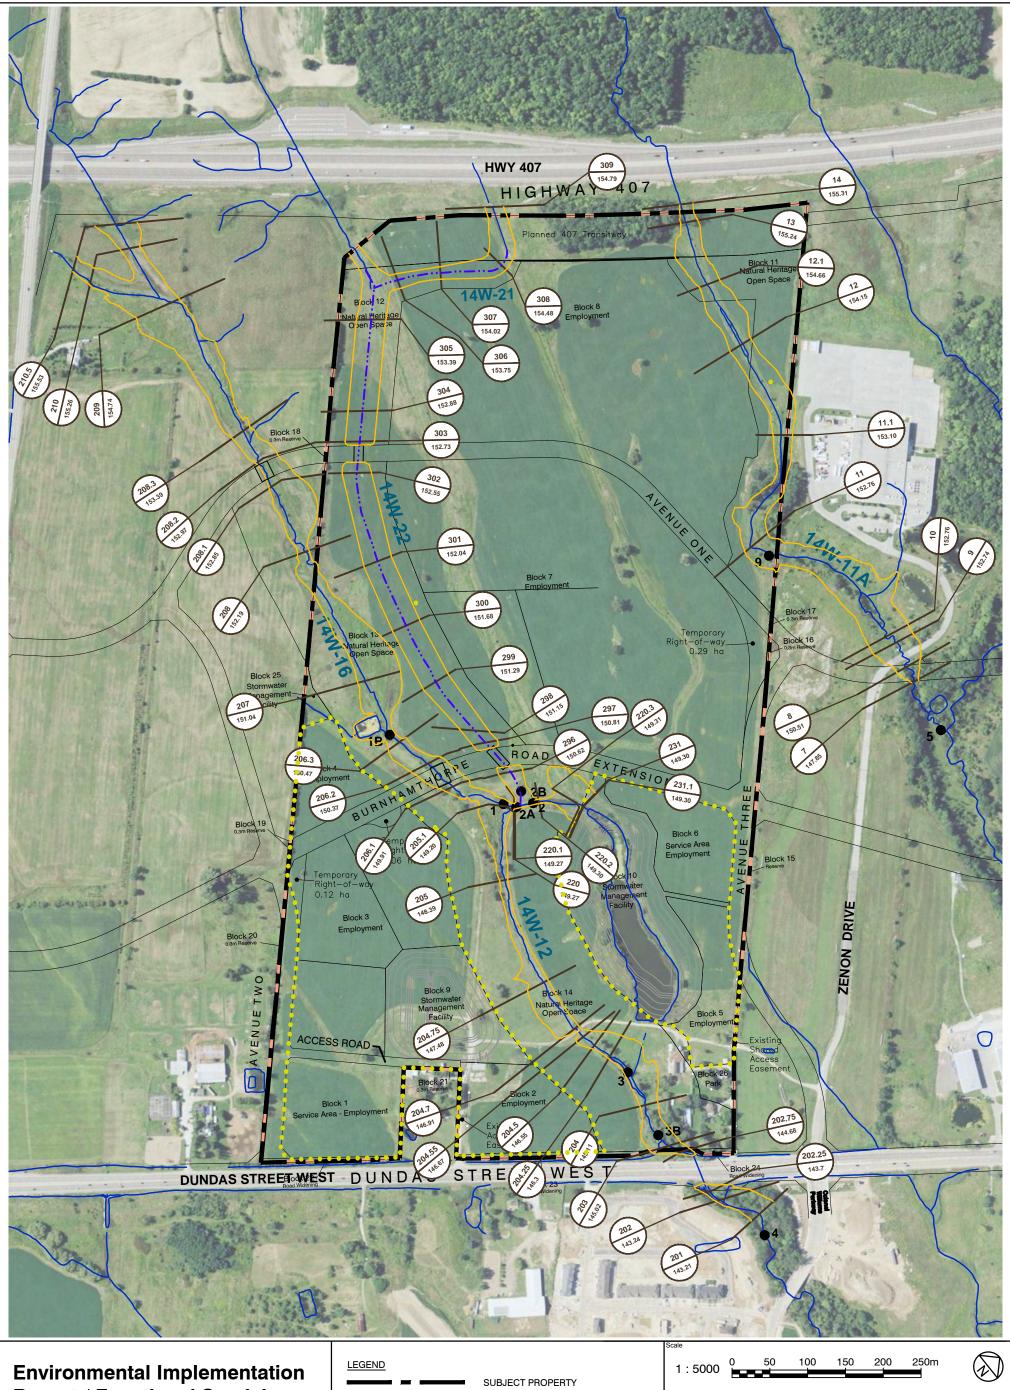
Hec-Ras Cross-Sections Interim Phase 1B condition

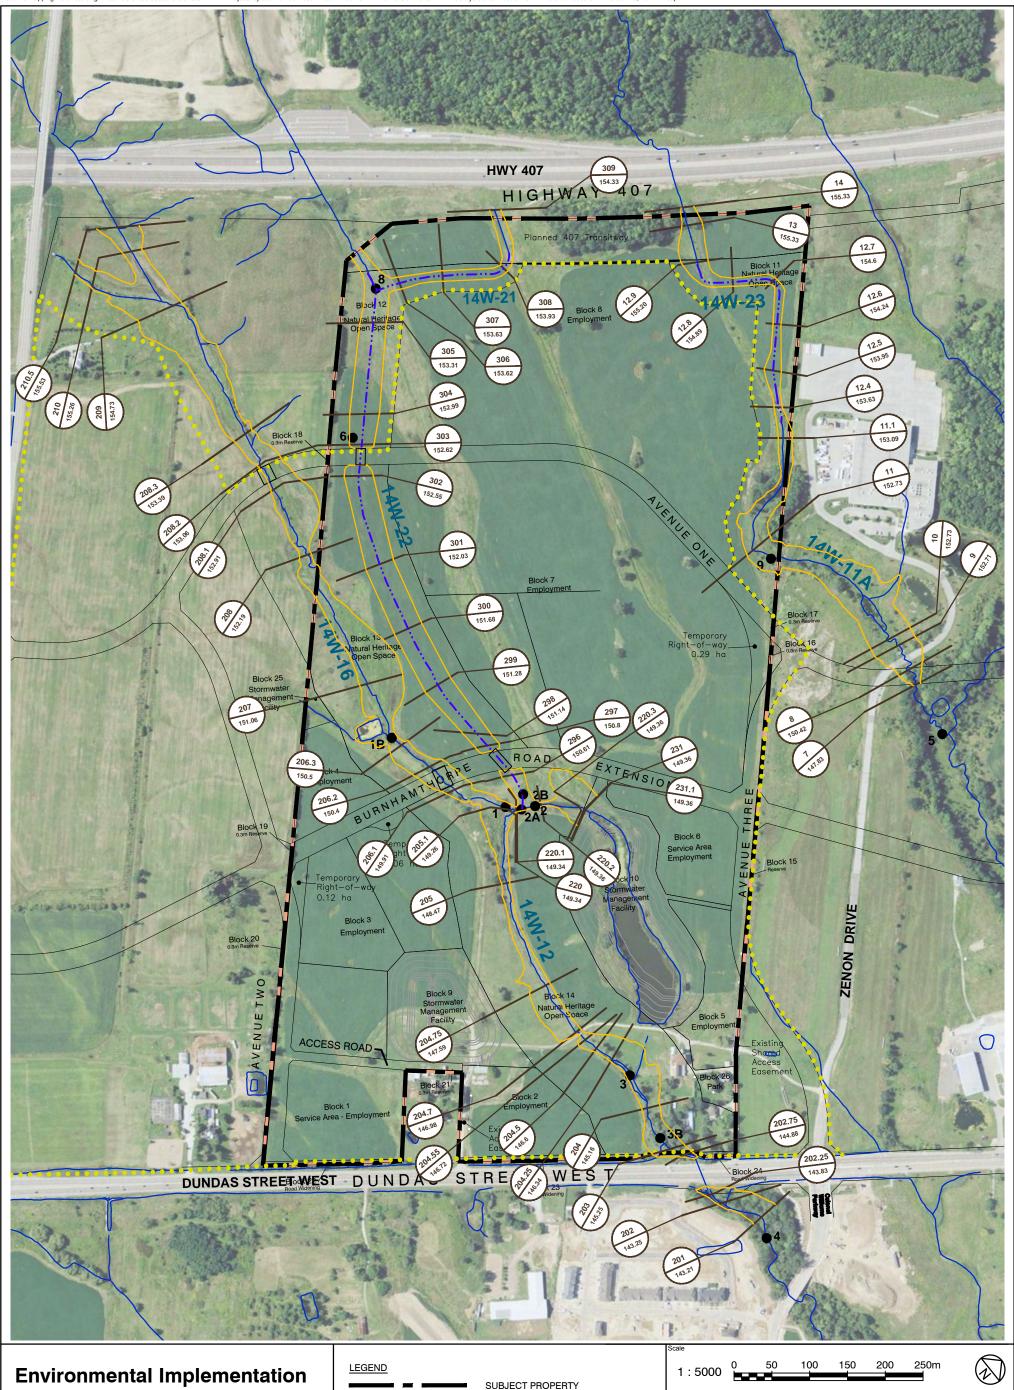
Hec-Ras Cross-Sections Ultimate condition

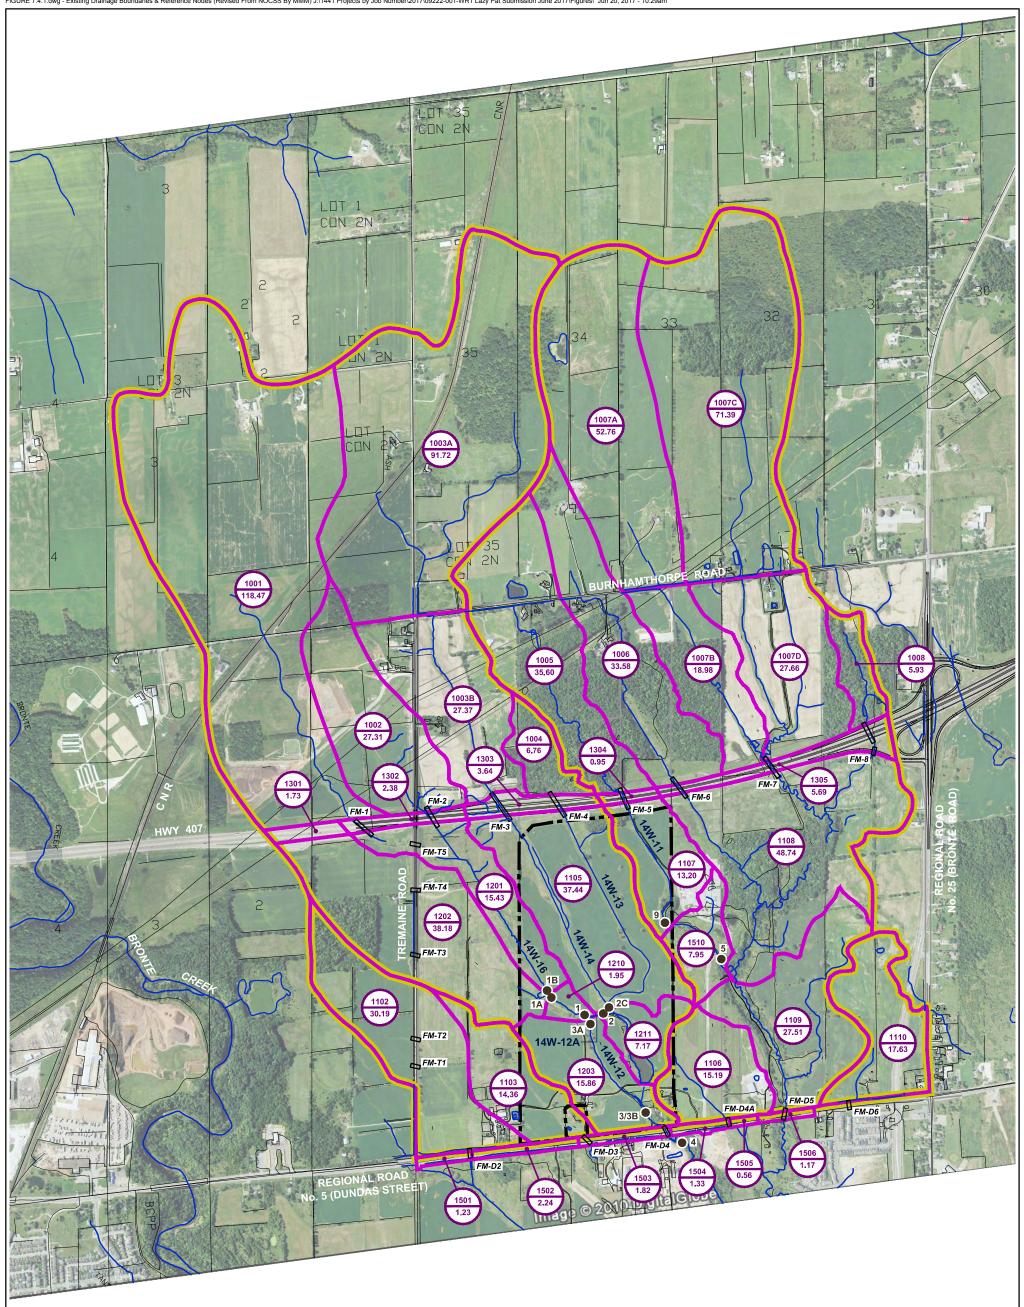
Existing Drainage Boundaries and Reference Nodes (Revised from NOCSS by MMM)

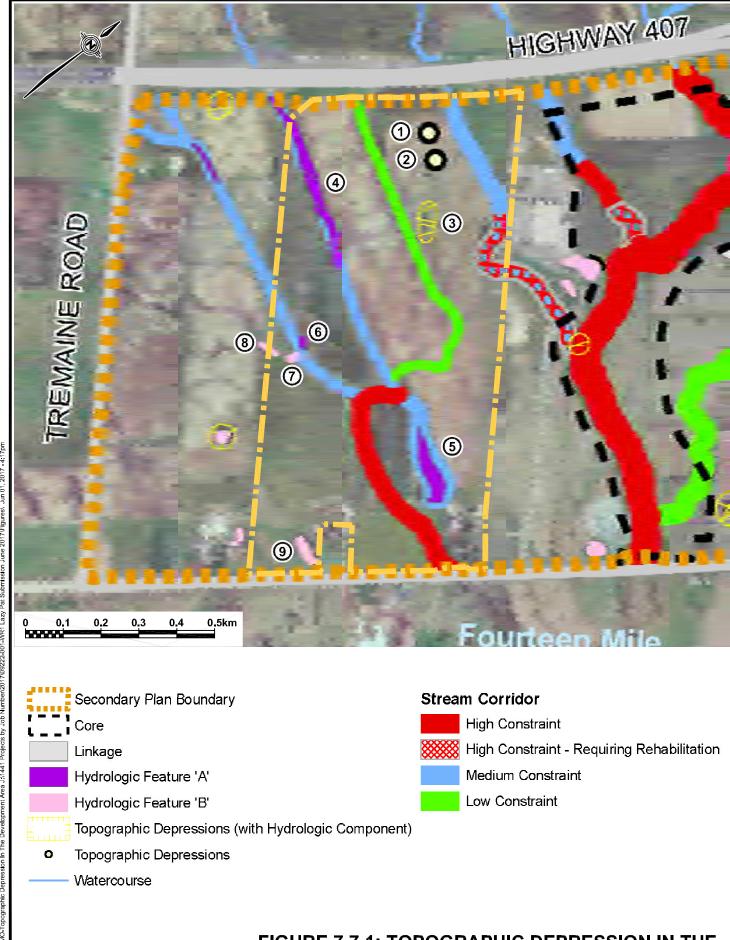
# FIGURE 7.7.1: TOPOGRAPHIC DEPRESSION IN THE DEVELOPMENT AREA

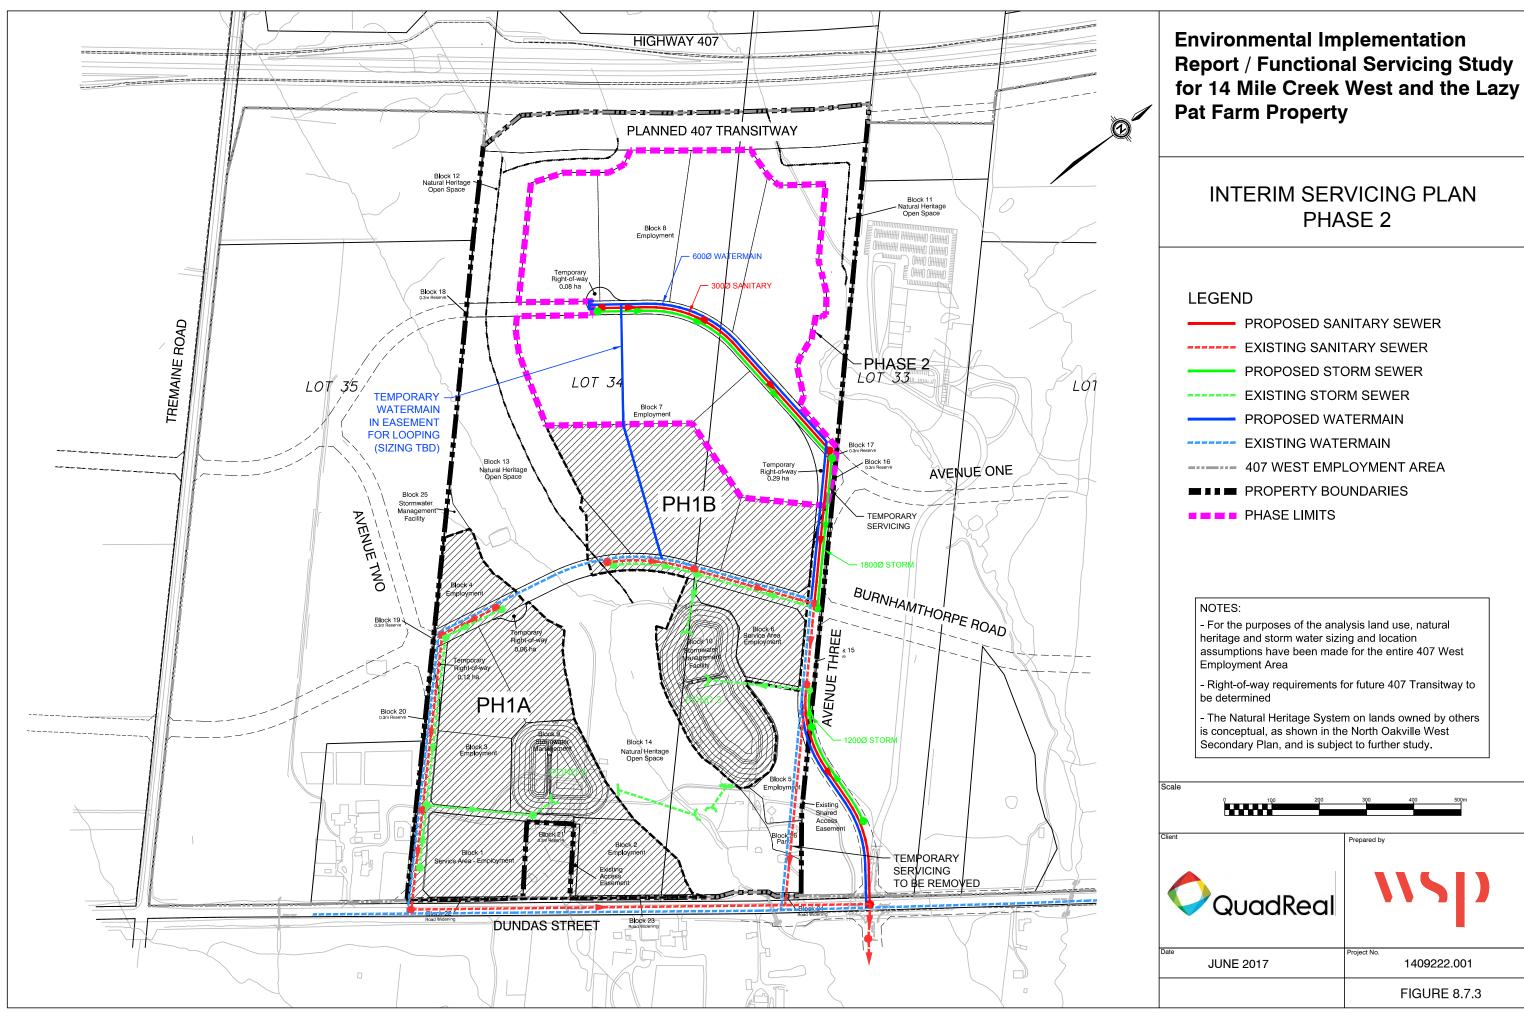
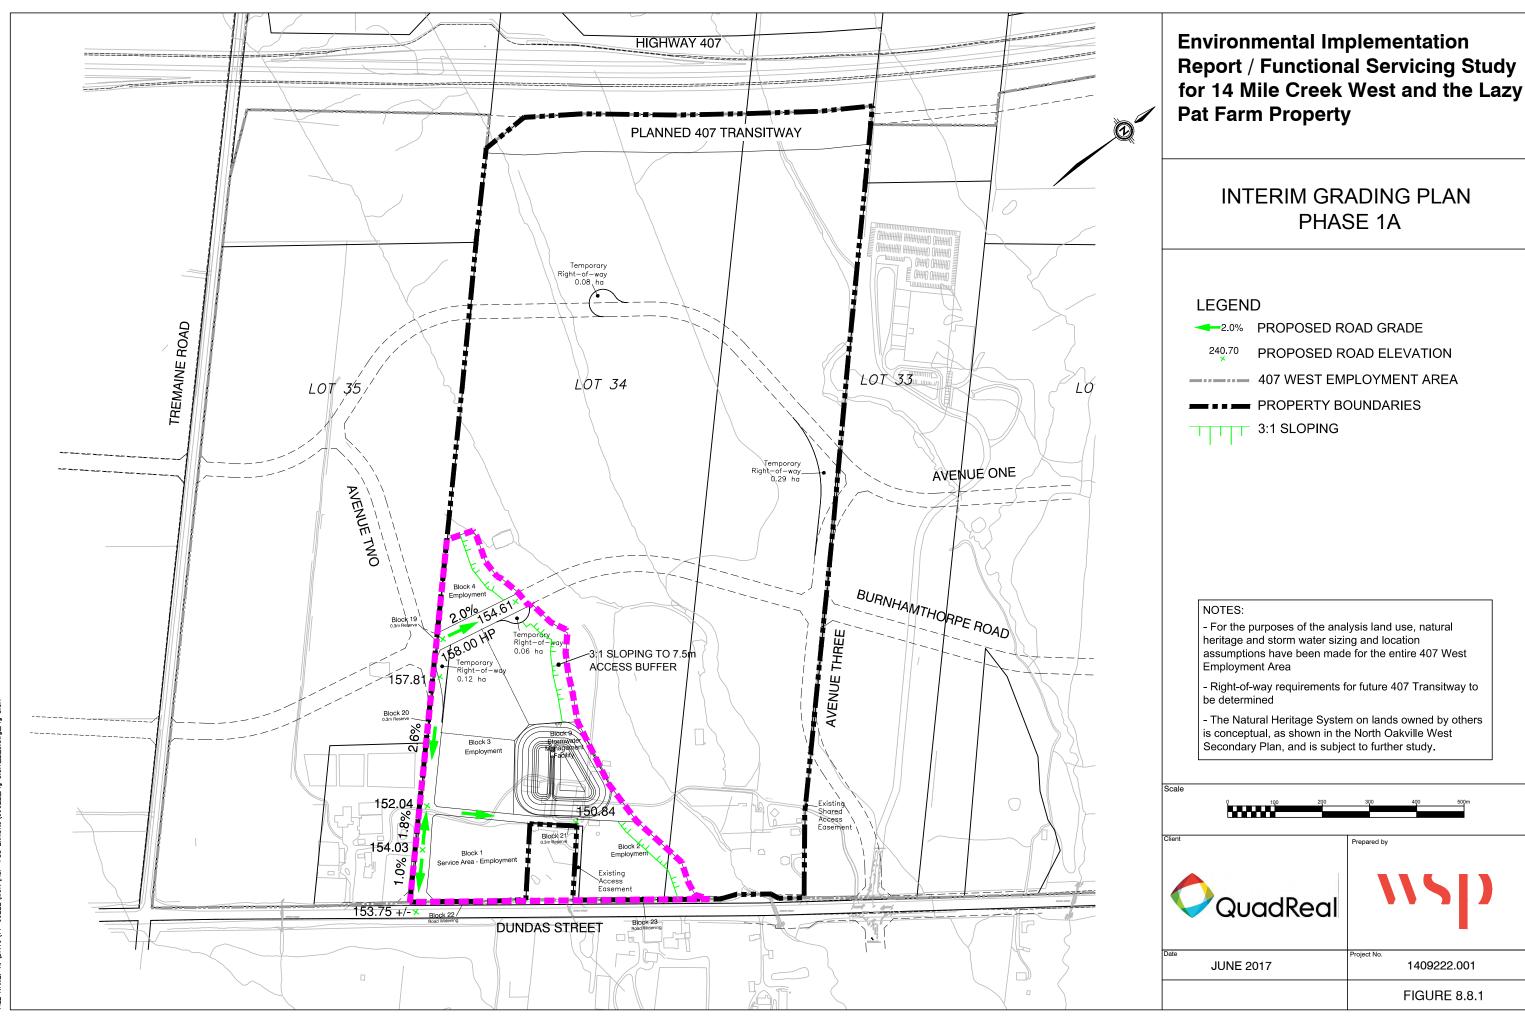
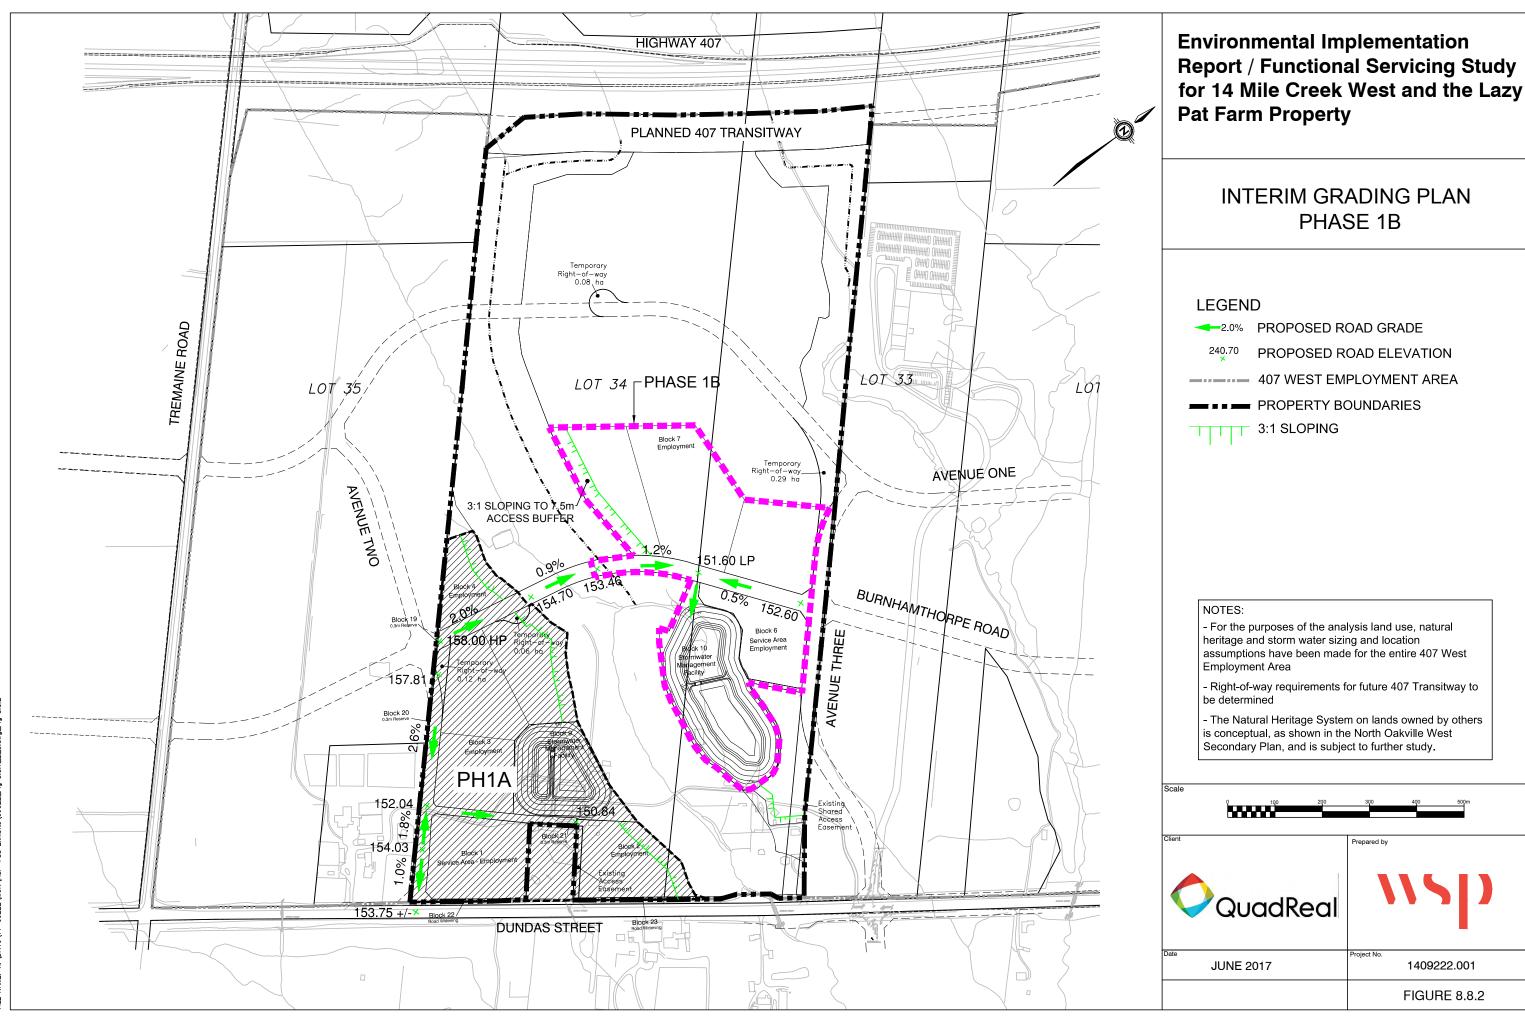
\DIV10\14-09222\MUN\ASP-FSS Exhibits\09022\_Fig 8.7.1\_2\_3.dwg\_

The overall servicing and grading design has considered the proposed phasing of the development. Municipal services, roads and grading works will be installed incrementally as needed to service development. Conceptual phasing of the servicing and grading are illustrated on Figures 8.7.1, 8.7.2, 8.7.3, 8.8.1, 8.8.2 and 8.8.3.
